WHEN IT RAINS, IT STAINS

By Bob Cusumano

Paints and coatings are applied for two reasons; to beautify and to protect the surface to which they were applied. In this article, we'll discuss a failure to beautify where discoloration is the nature of the failure and although the painting contractor is involved, did not cause the problem.

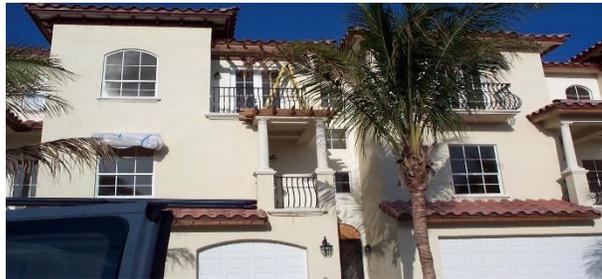
Photo 1

Marina Shores is an upscale residential community on the Intracoastal Waterway. As photo #1 shows, the exterior materials of construction include wood members composed of rough sawn cedar and stucco walls. The exterior wood surfaces are receiving a semi-transparent stain finish. Stucco surfaces are painted with an elastomeric coating system. It was noted that after it rains, a brown discoloration appears on exterior stucco surfaces. These stains seem to lighten over time, but reappear when it rains again. It was theorized that the stains were related to the semi-transparent stain.

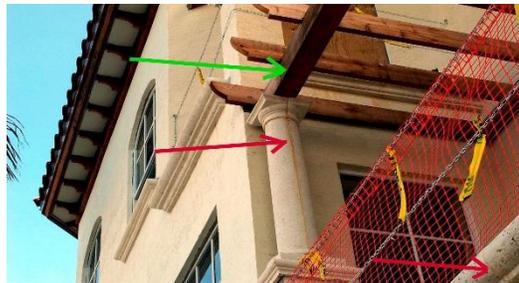
Photo 6

The wood members that are totally exposed to the weather, like the components of the wood trellises, are more prone to have water enter the wood and leach extractives than are the more protected components like wood fascia and soffits. The 6 inch by 8 inch trellis beams (the green arrow in photo #6) are particularly prone to staining due to the greater bulk of material. It was noted that a majority of the stains were located beneath these members on the various buildings.

It should be known that additional staining can occur. Limiting the amount of water that enters and exits the wood members will reduce the amount of discoloration. The semi-transparent stain applied to the wood is relatively porous and does not keep water from penetrating into the wood. A paint film of approximately 4 to 5 mils with an alkyd based primer would be necessary to eliminate water intrusion. However, this would drastically change the aesthetic appearance of the wood and coating delamination could result in some areas. A more practical measure would be to limit the amount of water than can enter the top face of the exposed wood beams. This could be effectively accomplished by installing a metal cap over these surfaces. A more economical, but probably less effective method, would be to apply a coating system that includes the use of a linseed oil primer to the top face of the exposed cedar members.
