Coatings  
Consultants  
Inc.

## LESSON LEARNED

By Bob Cusumano

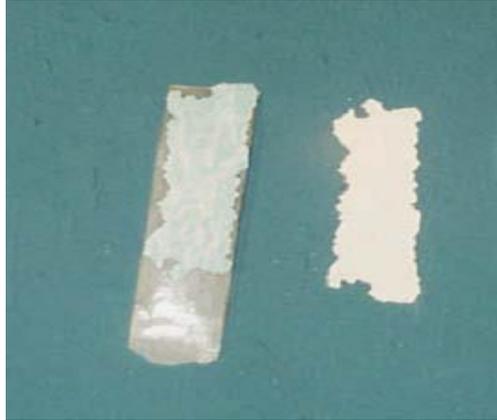
For consulting purposes, the adhesion by tape test should be precisely performed using the prescribed materials. For painting contractors assessing their own work or surfaces they intend to paint, making an X cut with a razor blade, applying a strong masking tape and then sharply removing it will suffice. A pass or fail system can then be used to evaluate the results. Photo 1 shows a result that would definitely be termed a "failed" test.

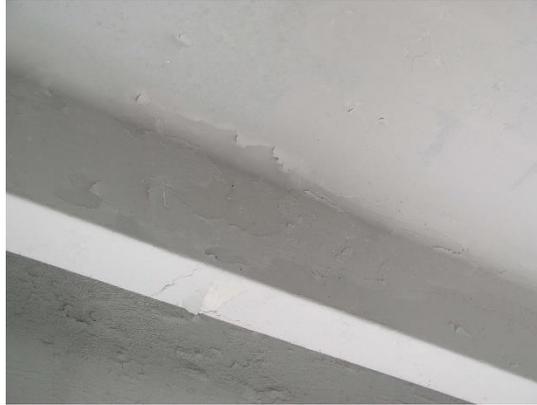
Photo 2

Now let's discuss the two incidents where the use of this test could have saved a lot of extra work and money. In the first case, a painting contractor repainted the ceiling of a large parking garage. The contractor pressure cleaned and applied an acrylic top coat. During the warranty period, extensive peeling occurred and the contractor provided paint chips for analysis. It was determined that the delaminated paint chips ranged from 20 mils to 50 mils thickness. Since the paint applied by the contractor would only have a thickness of 2 to 3 mils, it was evident that the newly applied paint was well adhered to the existing paint, but existing paint has delaminated with the new paint attached. There was heavy chalk found at the rear of all of the delaminated chips. Also the rear surface of the chips was very rough and contained many pinholes and craters. This was an indication that the delamination has occurred as a result of a cohesion failure within one of the original coats of paint. As paints age, they become brittle and lose their film strength. As more and more coats are applied, the weight and stress increase. When the stress exceeds the lowest bond strength between coats or the lowest cohesive bond within a coat, then delamination occurs. It was recommended that all of the poorly or marginally adhered coating be removed by high pressure water cleaning and that repainting be performed by priming with a penetrating masonry conditioner and then applying a top coat of latex paint.

Within six months of repainting, additional peeling of paint was evident (photo 2). This time the analysis included a site inspection. It was determined that some of the delaminating paint chips measured 20 or more mils, indicating that these were areas where the pressure cleaning performed was not aggressive enough to remove all of the marginally adhered existing paint. However, at other locations the delaminated chips only measured 2 to 3 mils, indicating that only the new paint peeled. Again, there was heavy chalk on the rear of all of the delaminated chips and in all instances a white paint remained on the concrete. A black cloth was repeatedly wiped against the now exposed white paint and each time a significant amount of chalk was transferred to the cloth. What had happened? The base coat of paint was so badly degraded that it was “dusting”. When chips were removed and measured with a microscope, it was determined that the chalk was 8 to 10 mils thick! Penetrating masonry conditioner will only penetrate a mil or two and therefore could not satisfy this thick chalk level. It was like trying to paint a beach!

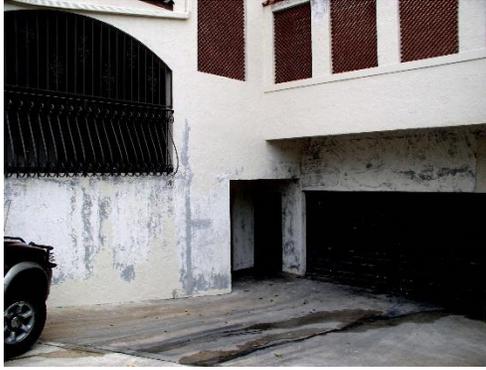
Photo 3

The second incident involves painting the exterior of a four story condominium with elastomeric coating. The specifications stated that all loose existing coating was to be removed by pressure cleaning with a minimum of 3,000 PSI. The contractor pressure cleaned the building with some existing coating being removed. The specified masonry conditioner had been discontinued, so the contractor thinned some of the finish coat, supposedly at a paint salesman’s suggestion, to use as a primer where chalky. When the building was ready for a final inspection, spontaneous peeling had already begun. Adhesion tests were then performed and they revealed that there was poor coating adhesion at most areas of the building. It was recommended that the painting contractor pressure cleaned the exterior of the building again using a turbo tip. Photos 3 and 4 show that a majority of the newly applied elastomeric coating was removed. The building had to be primed and refinished; definitely not good for the contractor’s wallet!

Two mistakes were made here. First, the pressure cleaning originally performed was not aggressive enough to remove poorly and marginally adhered existing paint. It was more of a wash down. Second, the thinned down elastomeric coating was an improper primer because it does not penetrate through any surface chalk to provide a sound base for the final coat.

The moral of the story is that both of these failures could have been avoided if a few simple adhesion tests had been performed on test areas. The results would have indicated that the preparation and priming performed did not provide satisfactory results. A razor blade and tape; that simple test could have saved thousands of dollars.
