Coatings
Consultants
Inc.

DANGER FROM BELOW

By Bob Cusumano

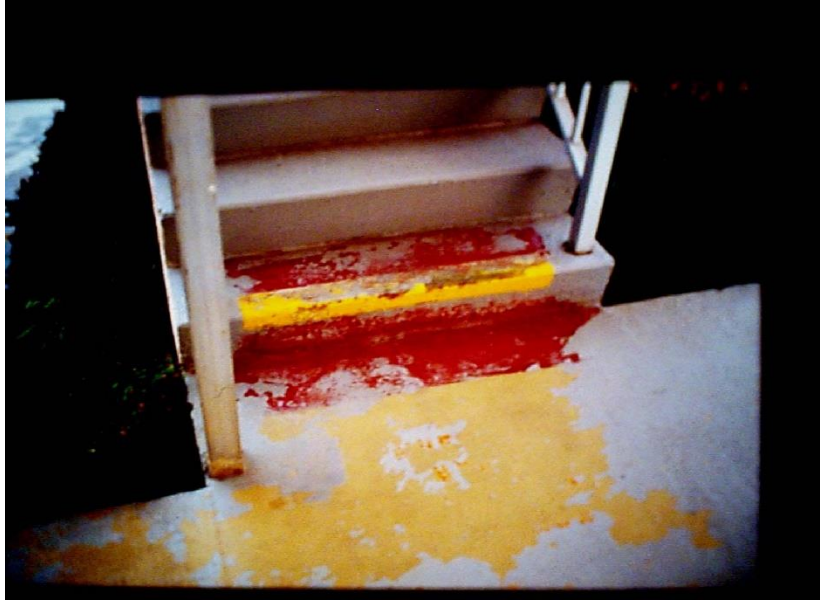
Observations made at the time of inspection revealed that most of the delamination occurred at areas of heavy traffic, including ground floor areas near stairs and the outer perimeter of ground floor walkways. Only isolated spots had failed on the second and third floors. The photograph below depicts the typical conditions found.

Now you know why they wanted to change the colors; that yellow and red combination just doesn't cut it!

Adhesion tests were performed at all floor levels. At the ground floor the results varied greatly. Some areas, particularly near the edge of the walkway were "poor", but the adhesion was found to be "good" adjacent to the building wall. At the second and third floors, the adhesion was found to be "good" at nearly all locations with just a few isolated spots having "fair" or low ratings.

Concrete floors were also tested for moisture content. At the first floor, the readings were low at areas where the paint had delaminated and got progressively higher towards the wall of the building. The readings were also high at perimeter areas where the paint had not delaminated. At the second and third floors, most readings were relatively low, with a few spots somewhat higher.

Examination of the delaminated floor chips revealed that only the newly applied alkyd gloss enamel had delaminated. Previous coats had remained intact with good adhesion.

The cause of the paint delamination at the Royal Palms was moisture migrating through the concrete walkway. The moisture could pass through the silicone acrylic stain, but was stopped at the alkyd/ stain interface. Because the moisture could not escape, delamination resulted. The moisture readings were low where the paint had peeled because the water was no longer trapped. Examination of the site indicated that there were sprinklers adjacent to ground floor walkways, a constant source of moisture. As is common, there was no vapor barrier beneath the concrete walks. pH testing on the rear of the delaminated paint chips yielded alkaline results, confirming moisture migration as the cause of the problem.
