Coatings Consultants Inc.

HERE'S THE RUB

By Bob Cusumano

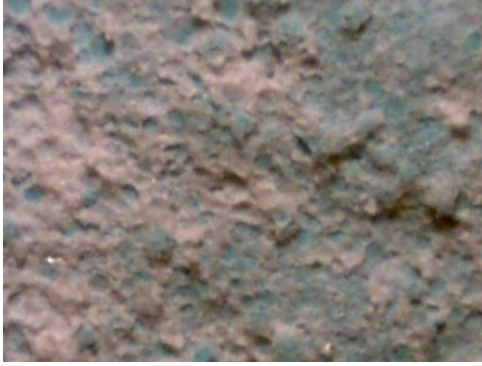
Photo 1

Some would describe this failure as a paint adhesion problem, but its actually a cohesive failure of the drywall texture beneath the paint. If a piece of masking tape is placed on the painted drywall and sharply pulled, then the paint is removed from the drywall. In this instance, light blue paint had been applied to the walls. Examination of the back side of the delaminated paint shows that white texture is attached to the rear of the paint as shown in photo #1. This is confirmed to be texture when a drop of acid is placed on the surface and violent fizzing occurs (photo #2).

What's occurring on this project is that when water is applied to the painted drywall surface for the purpose of removing scuff marks, it penetrates through the paint into the drywall texture beneath. The drywall texture is re-emulsified, and the paint literally floats from the surface. The cause of the problem is the water sensitivity of the texture. This is caused by the fact that not enough resin has been used in the texture. I've had some cases where all living units in a complex were equally affected. In other cases, only some of the units had this problem. Upon further investigation, some texture installers mix up a large bulk batch of texture in the morning initially adding enough acrylic resin to provide a sound texture. After spraying for a few hours, water is added for consistency. After this is done several times throughout the day, and no additional resin is added, the texture loses its hardness and cohesiveness and the failure we've described occurs.

Once paint has been applied to an improper texture, there is little that can be done to improve the performance because the paint acts as a shield against penetration of a different coating. It is possible to predict and prevent this mode of failure. Take a piece of soft black cloth and perform a chalk test by wiping across the surface. If a heavy chalk is transferred to the cloth, then that surface is likely to be trouble. Wet a cotton ball and rub gently on the texture, if it is easily

removed, then the texture is sensitive to moisture. As we've stated in previous articles, it's always wise to do a "patch test" prior to full scale production. If marginal texture is encountered, then treating the surface like a chalky exterior repaint and priming with a penetrating primer can yield good results. Check with your paint manufacturer to determine a suitable primer. Of course, if an extra coat is now required, you should seek additional compensation. As painting contractors, we have enough of our own problems without being burdened by those created by other trades.

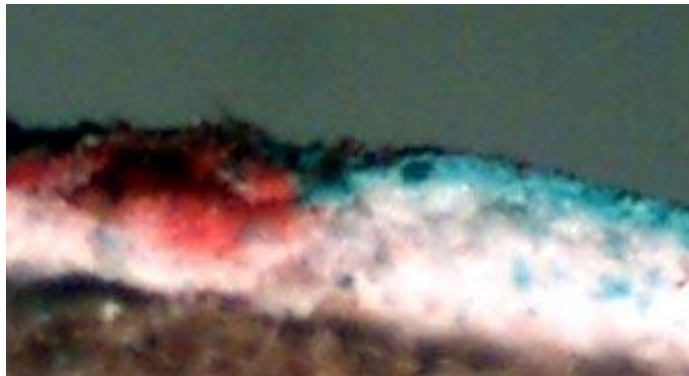
Photo 3

A cotton swab was dipped in red dye and taped to the surface of the drywall. After approximately fifteen minutes, the swab was removed and a section of the paint/drywall composite was extracted using a razor blade. Photo #3 shows a microscopic cross-sectional view. The various colored layers are the blue paint over the white drywall texture over the brown surfacing paper of the drywall. It can be seen that the red dye has penetrated through the paint and into the drywall texture.
