Coatings Consultants Inc.

HOW MUCH WATER IS TOO MUCH?

By Bob Cusumano

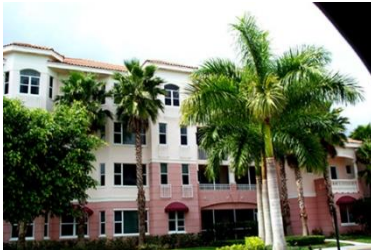
Photo 1

The Manor at Whispering Pines is a luxurious three-year-old assisted living facility in south Florida. The exterior of the building is panelized stucco construction created by using plastic reveals as shown in photo #1. Water intrusion has occurred within several living units and common areas in the building. The result has been mildewed drywall on the inside of the building that had to be removed and replaced. Attempts at remedial patching and caulking have proved to be unsuccessful.

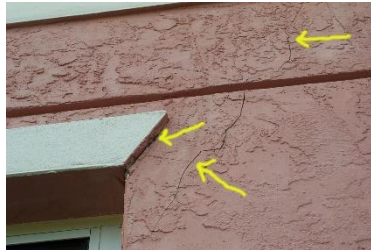
Photo 2

The water intrusion problem was discussed with the building manager whose belief, based on his observations during periods of water intrusion, was that water is penetrating through the stucco itself due to insufficient or improper paint application. During our inspection of the building exterior, we observed several defects such as cracks (photo #2), holes (photo #3), and voids at the ends and at joints between plastic reveals (photo #4) that could also admit water. The blotchy paint appearance as a result of alkali burn shown in photo #5 and the efflorescence depicted in photo #6 are signs of water intrusion.

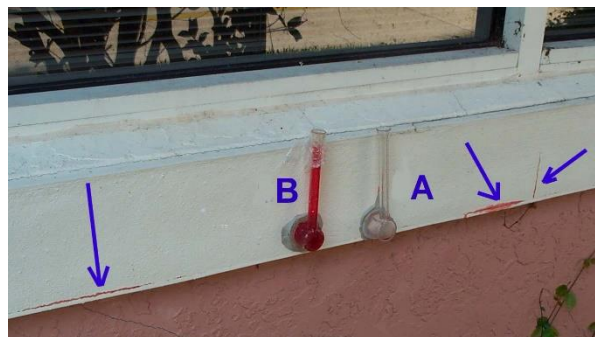
Photo 7

The maximum water absorption rate at each location was calculated. Small stucco core samples were taken at each sample location and examined to determine if water penetrated into the stucco. The Rilem tests performed indicated that the paint system currently applied to the exterior stucco allowed a slight amount of water penetration into the stucco substrate. However, the tests also showed that the amount of water passing through the coating and entering into the substrate is minuscule compared to the amount that can enter through defects in the stucco such as hairline cracks and small voids. Evaluating the test results showed that where stucco defects exist (location A in photo #7) versus adjacent samples where no defects exist (location B), up to 4,000 times more water can pass through a crack or void. Note that the red dye has traveled through the crack system and exited at locations several inches from the Rilem tube.

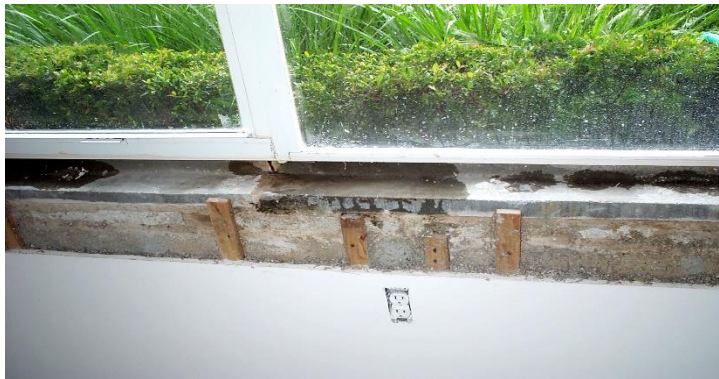
Photo 8

When water was directed at the very top of the frame, where metal to metal and glass to metal joints had not been caulked, a great amount of water intruded into the interior. The water was found to run down the enclosed interior portion of the window frame and drip out the bottom. Water spots appeared on the interior left side of the sill as well as beneath the vertical members that separate the three panes of glass (photo #8). Based on this testing, we were convinced that water is intruding through the window units themselves, not only at the window perimeters and through cracks and voids on the exterior walls.

Remedial work must include repair or replacement of the window units as well as the repair of all stucco defects. Repainting of the building will be necessary due to these repairs, not because of defects in the painting work itself. In this instance, the originally accused painting contractor was exonerated; the window manufacturer and the stucco contractor were not that lucky and will be held responsible for the extensive repairs necessary.
