THEY MAY BE WARPED, BUT THEY'RE NOT FUNNY

By Bob Cusumano

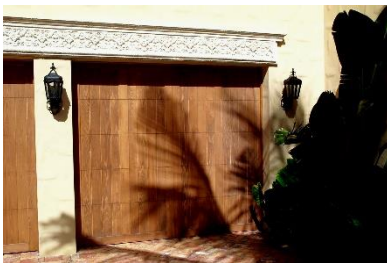
Photo 1

The three garage doors have a southern exposure meaning that they are exposed to the heat of the sun for several hours each day. As shown in photo #1, there is only a one-foot return over the doors, so they are directly exposed to the weather. A visual inspection of the doors revealed that the boards are warping exposing the edges as shown by the blue arrows in photo #2. A close up view is shown in photo #3.

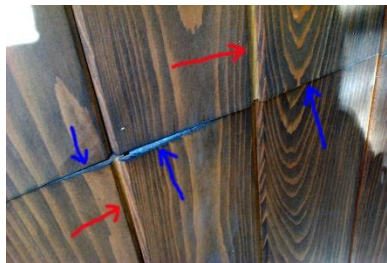
Photo 2

The red arrows in photo #2 and the yellow arrows in photo #4 show that gaps have opened where the boards join at the tongue and groove. Similar conditions were visible on all three doors, but were worse on the easternmost door. The red arrows in photo #5 point to cracks and splits that have developed in the wood.

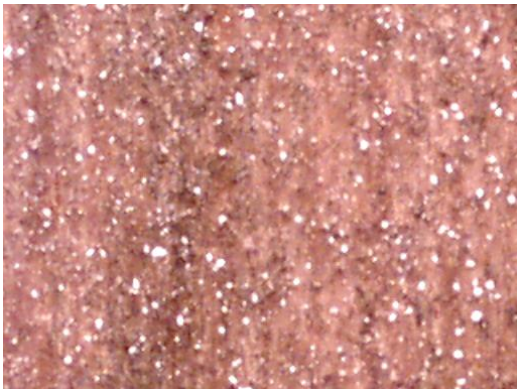
Photo 6

A board was removed from one of the doors in for examination and further testing. The board was examined using a stereo zoom microscope. Photo #6 shows the stained exposed face of the board at a magnification of 60X. The white round specks in the photo appear to be paint over spray on the surface of the door that occurred when nearby surfaces were painted. Photo #7 is a side view showing the penetration of the stain into the wood. The yellow line delineates the outer exposed face of the wood, while the green line indicates the depth of penetration of the stain into the wood. Upon examination, the rear, unexposed face of the wood does have a clear sealer as specified. The ends of the boards have been stained, but are obviously porous due to an open grain.
