Coatings Consultants Inc.

DROPS FROM ABOVE, BUT NOT HEAVEN

By Bob Cusumano

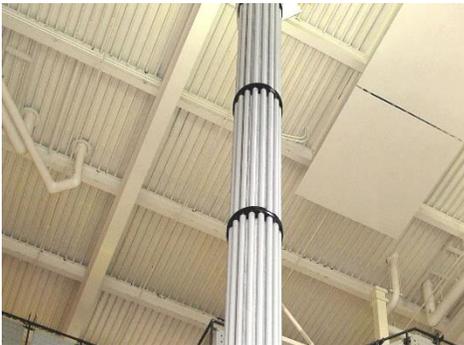
Photo 1

A new classroom building was constructed at a southern university. The atrium area of the building had an exposed steel ceiling composed of galvanized three inch vented ceiling deck with structural steel supporting members (photo 1). Light weight insulating concrete was placed on top of the steel deck thus becoming part of the roofing system. The steel beams and angles were to be shop cleaned and shop primed with an alkyd resin rust inhibitive primer. The galvanized deck and support steel were finish painted with an acrylic dryfall material. Within two years of completion, it was noted that areas of the supporting steel had rusted and delamination of the paint was evident.

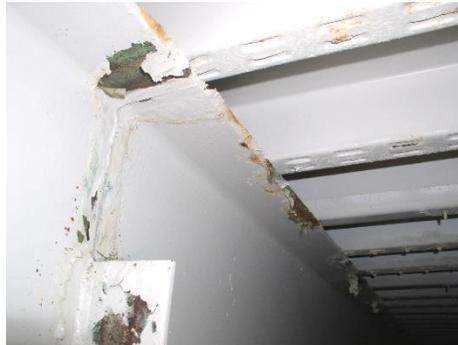
Photo 2

Accessible areas of the exposed ceiling were visually examined and defects were noted. The 12 inch beams in the ceiling appeared to be the most severely affected surfaces, as delaminating paint and corrosion were evident (photo 2). The slotted areas of the corrugated deck were also corroded and discolored. The tops of the 30 inch beams had some corrosion, but none was noticed on the face or bottoms of these beams. Only minute areas of discoloration were noted on pipes in the ceiling area.

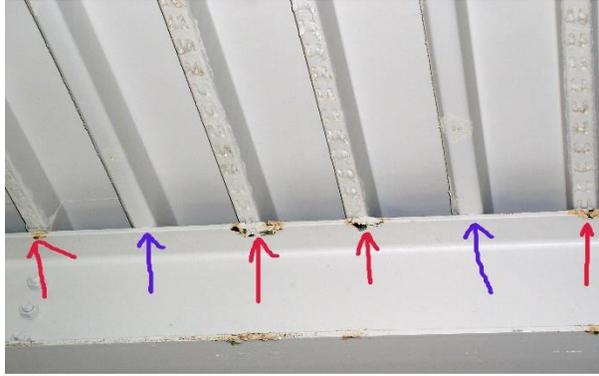
Photo 3

Upon closer inspection, it was noticed that where the deck was vented corrosion was present on the steel below as shown by the red arrows in photo 3. However, the blue arrows in that photo point to areas where no rust occurs on the beams where a solid rib is above. Small, highly alkaline stalactites were present at slots in the deck.

The cause of the saponification was highly alkaline salts that were dripped onto the support steel through slots in the deck and at junctures where two pieces of deck overlap. Alkyd resins such as that used in the rust inhibitive primer are particularly subject to saponification. The degradation of the primer resulted in spontaneous paint delamination and corrosion.

It was not determined whether this excess moisture was due to roof leaks or retained moisture in the concrete above the deck. Prior to repainting with a high performance system, it was necessary to determine that the concrete above the deck had sufficiently dried out and that the alkalinity was neutralized.

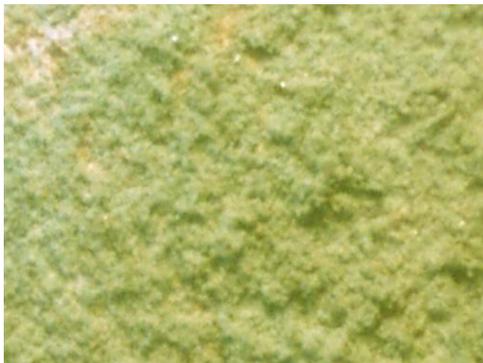
Photo 4

Delaminated paint chips were examined with a microscope. It was found that the rust inhibitive primer had become very friable and easily disintegrated (photo 4).

A wet sample of rust inhibitive primer and the delaminated paint chips were tested to determine if the cause of the degradation of the primer was saponification. Saponification is the chemical degradation of a coating due to high alkalinity and moisture. The coating becomes "sticky", then brittle when dried and loses its adhesion. The testing confirmed that saponification of the primer had occurred.

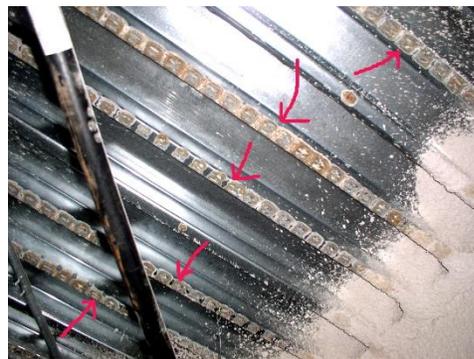
Photo 5

An area of unpainted ceiling deck above an acoustical tile ceiling was also examined. As shown in photo 5, corrosion was apparent at slotted portions of the corrugated ribs at these unpainted areas.
