Coatings Consultants Inc.

PEELING CEILING

By Bob Cusumano

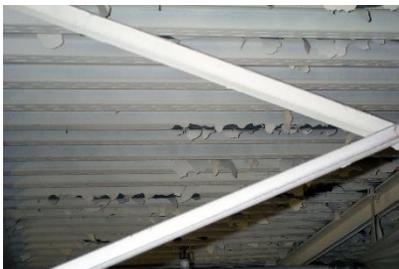
Photo 1

A visual inspection of the painted ceilings revealed that the paint was peeling from galvanized metal ceiling decks (photo #1) and galvanized metal pipes (photo #2), but not from primed steel joists (photo #3).

Infrared spectroscopy confirmed that the paint that had been applied to the exposed metal ceiling surfaces at the gymnasium facility was an alkyd dry fall product. This was contrary to both the painting specifications and the paint submittal made by the paint manufacturer. Unfortunately, when alkyd paint is applied directly to a galvanized surface, then a failure known as saponification will occur. Saponification is a chemical degradation of the alkyd resin in the paint.

Unfortunately for the painting contractor, all of the options for remedial action are costly. All of the paint applied to the galvanized deck, ducts and other surfaces must be removed as applying additional paint on top will only further compromise the adhesion. The options available include Now let's look at the remedial options available, keeping in mind that the facility is now open and must remain so when the work is performed. Obviously, all of the existing paint must be removed from the galvanized ceiling deck and pipes. Potential remedial measures available to the painting contractor include hand scraping, power tool cleaning, chemical stripping, and abrasive blasting. All of these options are expensive either due to the low production rates achieved or the extensive cover up of finished floors, walls, and other surfaces that must be accomplished.

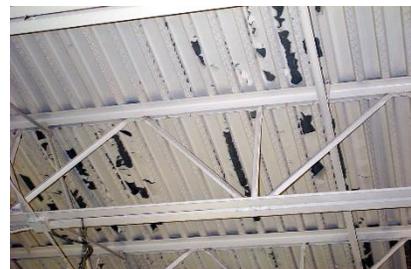
Photo 3

Because the steel joists are ferrous metal or steel rather than galvanized and factory primed rather than bare, the alkyd dry fall did not saponify and is well adhered to these surfaces.

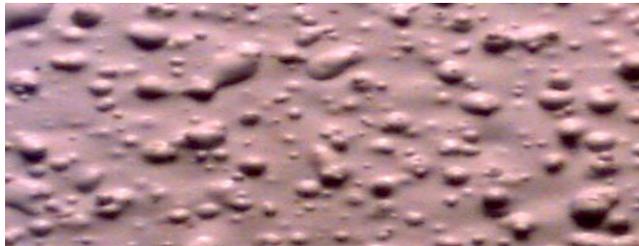
Photo 5

The paint chips were then visually examined using a stereo zoom microscope. No contamination was noted on the rear of the delaminated paint. From examination of the face of the paint chips, it is evident that the paint was spray applied, contrary to the project specifications. Photo #4 is a view at 60X magnification. The round, rough appearance is typical of the spray application of a dryfall paint. Observation of a cross section of the paint indicates that there is only one paint product throughout; that is, individual prime and finish coats could not be discerned and therefore no primer was applied in accordance with the contract requirements.
