Coatings Consultants Inc.

ONE FROM COLUMN A By Bob Cusumano

This case involves a large addition to a mansion on the Florida coast. Part of the job included the construction of a long colonnade walkway that led from the main house to the pool. The roof of the walkway was supported by columns constructed of poured concrete (photo #1).

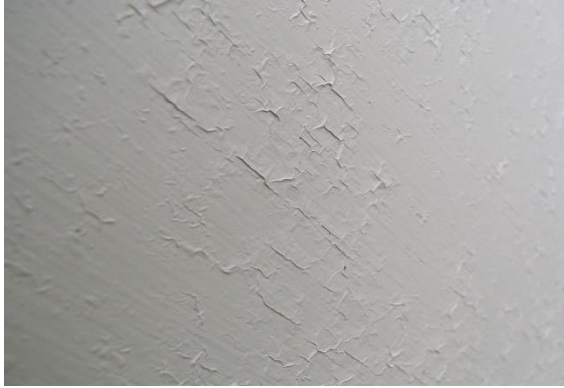
Photo 2

At the time we examined the columns, there was bubbling and wrinkling of the paint at some locations (photo #2) and at other locations, the paint had either already delaminated or been scraped off (photo #3).

1. All paint and patching material should be removed. Unfortunately, large areas of the columns were patched, not just the voids. Scraping is probably the most effective method.
2. All bare concrete surfaces should be acid etched to roughen the surface similar to 120 to 80 grit sandpaper. If the acid does not fizz when applied, then the butcher's wax is interfering with the chemical reaction and must first be removed using solvent. After acid etching, surfaces must be thoroughly flushed with clean potable water, neutralized if necessary, and allowed to thoroughly dry.
3. All pores, voids, and "bug holes" should be patched with a high strength cementitious patching compound, taking care to only fill voids and to remove any excess patching material.
4. Columns should be primed with an exterior acrylic bonding primer and finished with an acrylic latex house paint in the desired sheen.

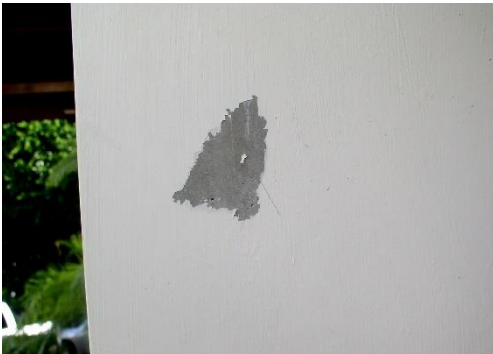
Photo 4

Whenever paint delaminates, it is important to determine where the delamination has occurred. In some instances, where the adhesion was poor, the delamination occurred back to bare concrete as shown in photo #4. The surface of the concrete was found to be very smooth at these spots. In other instances, the delamination occurred within the layer of patching material as shown in photo #5.

Another contributing factor to the poor adhesion of the paint to the concrete columns is the lack of mechanical adhesion. A large percentage of paint adhesion is achieved by its mechanical bond to the surface to which it is applied. When that surface is rough and porous, then good adhesion is established. When that surface is smooth and glossy, as it was found to be in this instance, then adhesion is compromised.

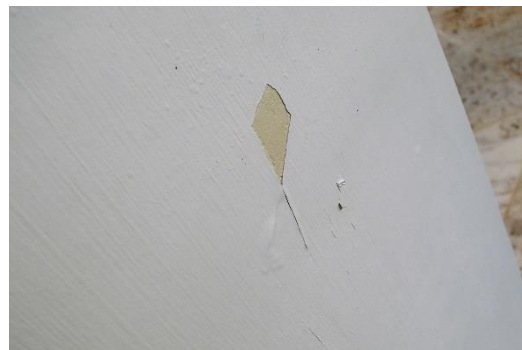
Photo 5

Saponification is one cause of the paint delamination. Saponification is the chemical degradation of a coating due to high alkalinity and moisture. The coating becomes "sticky", then brittle when dried and loses its adhesion. Alkyd and oil base paints are particularly prone to this problem and should not be utilized when moisture and alkali are present. The moisture and alkali have also affected the patching material, causing it re-emulsify and suffer a cohesive failure.
