## DEALING WITH A STICKY SITUATION

By Bob Cusumano

A national company that owns personal storage facilities around the country recently built a three story building in a southern coastal community. The building was constructed of concrete block and stucco with metal pan ceilings and poured concrete floors.

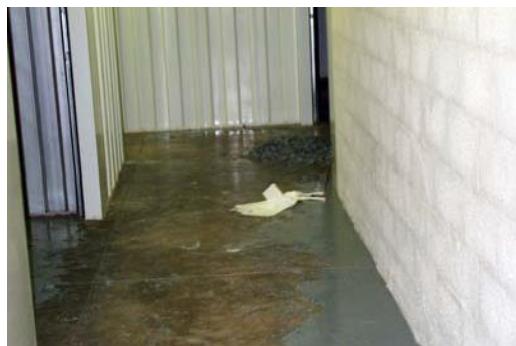
Photo 1

At the time of our inspection, scraping off of the existing applied coating had begun as shown in photo #1. Photo #2 shows the condition of first floor areas prior to scraping; where large areas of paint delamination are visible.

Prior to recoating these floors with either a stain or an epoxy system, all existing coating had to be removed. The surface of the concrete should be roughened, preferably by shot blasting. The pH and moisture levels should be monitored prior to recoating.

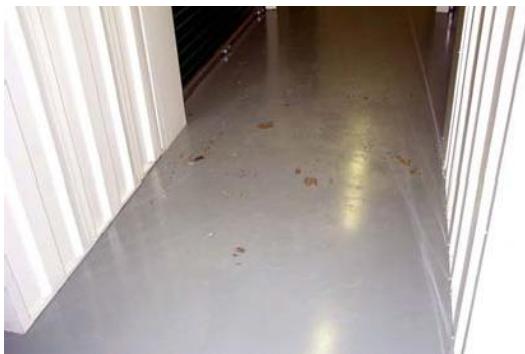
Photo 3

Much of the coating on the second floor appeared to be intact with no delamination. However, at some locations a color and gloss difference was noted which are the initial signs of saponification. On the third floor, delamination was prominent at many areas as typified by photo #3. At some locations there were distinct variations in color and gloss and the coating had become soft and sticky as shown in photos #4.

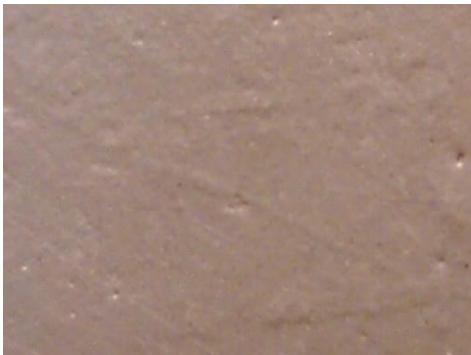
Photo 5

### **1. Adhesive failure of the alkyd enamel to the clear alkyd sealer**

The data sheet for the sealer states that when used as a primer, the product is to be thinned with 1 to 2 quarts of xylene per gallon. The purpose of thinning is to encourage penetration into the concrete and avoid the establishment of a glossy surface. Coatings do not adhere well to a smooth glossy surface as no mechanical adhesion is attained. At this facility, the sealer was applied too heavy, resulting in the top coat of alkyd enamel not establishing good adhesion to the sealer. Photo #5 shows that the rear of the delaminated enamel is extremely smooth. Photo #6 shows that the sealed concrete surface from which the enamel topcoat delaminated is also very smooth with only a few scratches visible from the sanding performed as surface preparation.

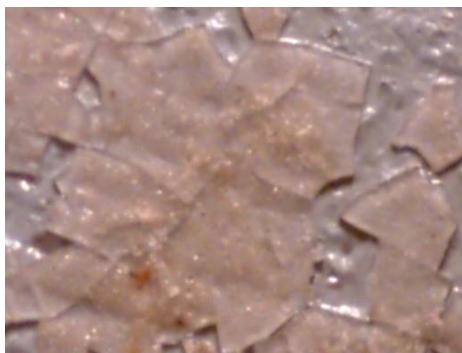
Photo 7

## 2. Adhesive failure of the sealer to the bare concrete.

At some locations the sealer lost its adhesion to the bare concrete floor. Photo #7 shows the heavy buildup of sealer with stress cracks visible on the rear of an adhesion test sample. Optical examination of the surface of the concrete at many areas revealed that the surface was extremely smooth and slick. At these locations, the sanding performed was not sufficient to adequately roughen the concrete surface to establish a mechanical adhesion to the substrate. This is supported by many of the pull test results where failure occurred at relatively low pressure removing both the topcoat and the sealer. The floors have a smooth troweled finish. As stated on the sealer data sheet, acid etching of the concrete is recommended in these situations.

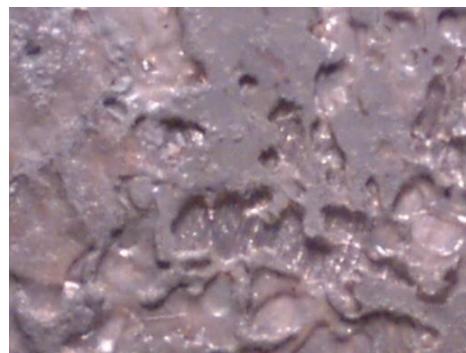
Photo 8

## 3. Saponification of both the sealer and the alkyd enamel.

On the third floor, some of the existing coating had become wet and “sticky”. This is due to a phenomenon known as saponification that occurs when a combination of moisture and a highly alkaline condition resulting in total chemical degradation of the coating. The high moisture and pH readings at many locations support this contention. Color and gloss changes occur as a part of saponification. Photo #8 shows the deformation to the paint film that occurs.

Some coating resins are more susceptible to saponification than others. The use of a silicone acrylic stain, as originally specified, would have reduced the likelihood of saponification.
