Coatings Consultants Inc.

LEARNING PROBLEM

By Bob Cusumano

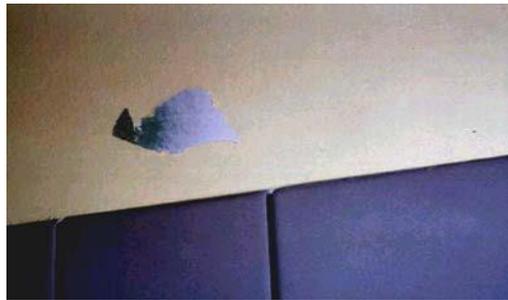
Photo 1

Areas of Building 1 were painted approximately four weeks after plastering was completed. The painting contractor indicated that the material method of application was spray and back roll. Within thirty days of paint application on wall areas of Building 1, bubbles were evident and areas of paint started to peel (photo #1). A short time later, it was discovered that walls in Building 2 had also begun to peel.

The adhesion tests performed indicate that there are many areas where the adhesion of the applied paint is poor and further delamination is likely. In all instances where the adhesion was found to be poor, there was plaster adhered to the rear side of the delaminated paint and the remaining substrate was found to have a heavy to moderate surface chalk.

The testing performed indicates that the paint has adhered to the surface of the plaster, but that the plaster itself has low cohesive strength. The delamination that occurs when adhesion tests are performed is due to fracturing within the plaster itself, not due to poor adhesion of the paint to the face of the plaster. Unfortunately, the application of additional coats of paint at this time, rather than rectify the situation, would in fact worsen it. Each additional coat of paint increases the amount of surface stress. When the stress exceeds the strength of the weakest link of the chain, delamination occurs. In this instance the weak link is the cohesive strength of the plaster.

Had the condition been noted before the paint was applied, the use of a masonry conditioner as a primer would have penetrated and may have added strength to the plaster, thus providing a more suitable surface for painting. Now that paint has been applied, any remedy must include removing the existing paint.

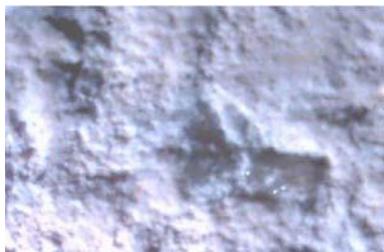
Photo 2

The rear of delaminated paint removed during the adhesion tests was examined using a stereo zoom microscope. The presence of plaster on the rear of all paint samples was readily identifiable due to its crystalline nature (see photo #2) and was confirmed by the violent reaction when a drop of mild hydrochloric acid was placed on the surface (photo #3). Photo #4 shows the rear of the paint sample after the plaster has been removed.

The average thickness of the plaster adhering to the rear side of the delaminated paint was measured to be 2.9 mils, indicating that the delamination occurred well beneath the paint/plaster interface.
