## RUSTING PROBLEM

By Bob Cusumano

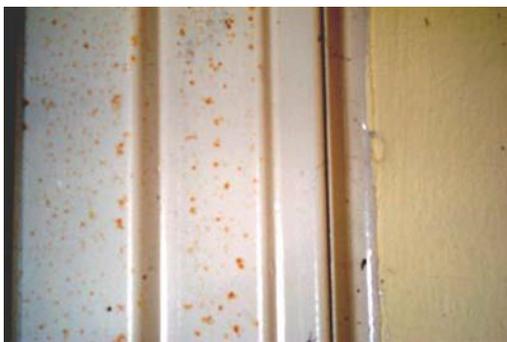
Photo 1

A visual site inspection of the door frames confirmed that a majority of them exhibited varying degrees of rusting, with some being quite severe as shown in photos #1 and #2. Rusting was more severe on the exterior portions of the frame, although some corrosion was also observed on the interior side of these exterior door frames.

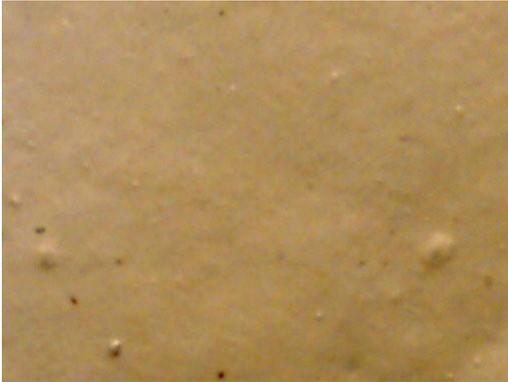
Photo 3

At this point, the questions that needed to be answered were "Did the corrosion develop as a result of defects in the field applied paint coats, thus being the responsibility of the painting contractor?" or "Was the rusting present as a result of improper surface preparation at the shop"? To answer these questions, several frames that did not exhibit visible rusting were selected for testing. The exposed surface of the paint was examined with a stereo zoom microscope and found to be relatively smooth and free of film defects as shown in photo#3.

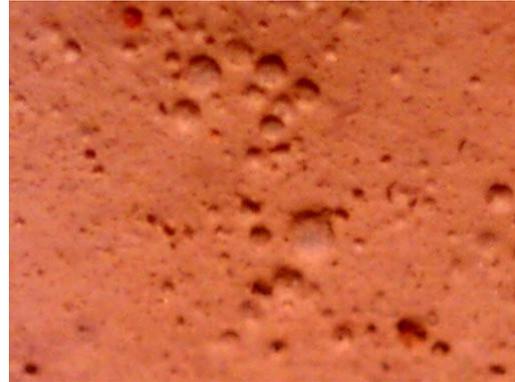
Photo 4

The top coats were then removed using denatured alcohol. This confirmed that the top coats were latex as specified. Alkyd paints and other resins like epoxies and urethane would be unaffected by exposure to denatured alcohol. The now exposed surface of the field applied rust inhibitive primer was found to have several craters, as shown in photo #4, but none of the pores penetrated entirely through that coat of paint. Denatured alcohol did not soften and remove this coat suggesting that it is indeed an alkyd as specified.

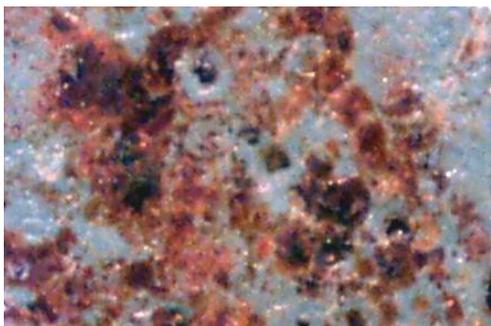
Photo 5

The red field applied primer and the gray factory applied primer were then carefully removed from the steel frame using a razor blade. On the rear of the paint sample, rust was attached to the gray factory primer as shown in photo#5.

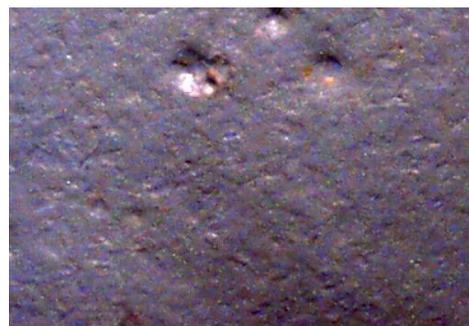
Photo 6

This rust was dissolved by placing dilute hydrochloric acid on the rear of the chip. This reacts with the iron oxide but does not affect the paint. The rear side of the factory primer was then re-examined under the microscope and found to be relatively rough as depicted in photo #6. This

indicates that the primer was applied over rust and mill scale rather than to a smooth surface. Test samples from other frames had similar results.

Based on our observations and testing, it was our opinion that the rust initiated beneath the coating rather than through pinholes or defects in the coating itself. This contention is based on the deformation at the back of the paint film noted above and the heavy rust found beneath the primer. Inconsistent surface preparation of the steel frames prior to the application of factory applied primer could account for the sporadic rusting noted.
