OUTSMARTING YOURSELF

By Bob Cusumano

This month's case history is an example of what problems can occur when you get creative with a project's painting specifications.

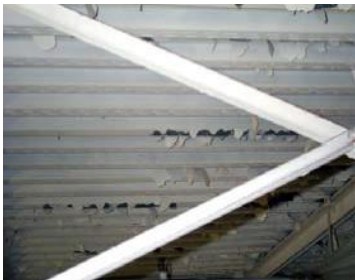
Photo 1

A visual inspection of the painted ceilings revealed that the paint was peeling from galvanized metal ceiling decks (photo #1) and galvanized metal pipes (photo #2), but not from primed steel joists (photo #3).

Based on our observations and testing, the paint applied to the exposed metal ceiling surfaces at the bus maintenance facility was an alkyd dry fall product. It is further our opinion that no primer was applied. When a traditional alkyd paint is applied directly to a galvanized surface, then a failure known as saponification is likely. Saponification occurs when the alkyd resin is

Now let's look at the remedial options available, keeping in mind that the facility is now open and must remain so when the work is performed. Obviously, all of the existing paint must be removed from the galvanized ceiling deck and pipes. Potential remedial measures available to the painting contractor include:

1. Hand scraping and/or power tool cleaning - these methods are impractical due to the large size of the ceiling, would be slow and the result in a high labor cost.
2. High pressure water blasting- this method is impractical because there are finished office spaces immediately below failing ceiling surfaces that would be damaged by water intrusion from above and would require extensive cover up.
3. Chemically stripping- this method would be both messy and expensive.
4. Abrasive blasting- must use an abrasive like plastic pellets that will not damage or remove the galvanizing.

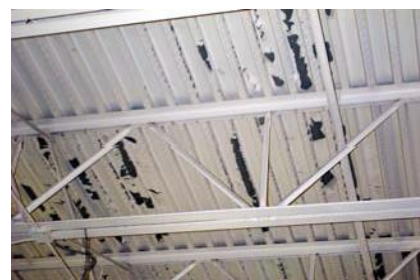
Photo 3

chemically attacked. Because the steel joists are ferrous rather than galvanized and factory primed rather than bare, the alkyd dry fall is well adhered to these surfaces.

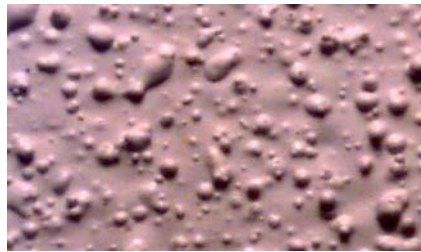
Photo 4

The paint chips were then visually examined using a stereo zoom microscope. No contamination was noted on the rear of the delaminated paint. From examination of the face of the paint chips, it is evident that the paint was spray applied. Photo #4 is a view at 60X magnification. The round, rough appearance is typical of the spray application of a dry fall paint. Observation of a cross section of the paint indicates that there is only one paint product throughout; that is, individual prime and finish coats could not be discerned.
