# Coatings Consultants Inc.

## ADHESION VERSUS SCRUBBABILITY

By Bob Cusumano

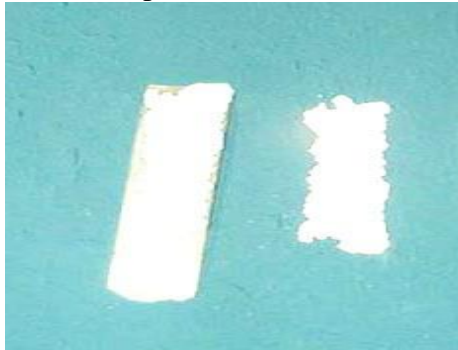
Photo 1

Examination of the back side of the delaminated paint shows that white texture is attached to the rear of the paint as shown in photo #1.

Examination of the wall area where the test was conducted revealed that part of the texture was still present on the wall. Therefore, rather than an adhesion problem, that is the paint losing its bond to the texture. We really have a cohesion problem within the drywall texture itself. In this instance the adhesion of the paint to the texture was stronger than the cohesive force that holds the texture together.

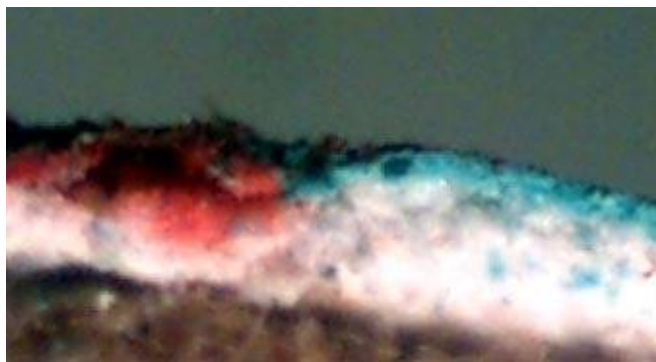
Photo 2

When the paint over the drywall texture is undisturbed, the cohesion of the texture is sufficient to prevent spontaneous delamination of the paint. However, when the painted drywall is stressed by the action of scrubbing, then delamination occurred. It was also theorized that the absorption of water during the scrubbing process was a factor in the failure. To confirm this condition, a cotton swab was dipped in red dye and taped to the surface of the drywall. After approximately fifteen minutes, the swab was removed and a section of the paint/drywall composite was extracted using a razor blade. Photo #2 shows a microscopic cross-sectional view. The various colored layers are the blue paint over the white drywall texture over the brown surfacing paper of the drywall. It can be seen that the red dye has penetrated through the paint and into the white drywall texture.

What's occurring on this project is that when water is applied to the painted drywall surface for the purpose of removing scuff marks, it penetrates through the paint into the drywall texture beneath. The drywall texture is re-emulsified, and the paint literally floats from the surface when it is scrubbed. The cause of the problem is the low cohesion and water sensitivity of the texture.

In this instance, not enough acrylic resin was used in formulation of the texture. Similar failures occur when wallcovering is applied. The water in the paste wets the texture and the inherent stress of the wallcovering causes delamination.

Once paint has been applied over a weak texture, there is little that can be done to improve the overall performance because the paint already applied acts as a shield against the penetration of any additional coating. It is however, possible to predict and prevent this mode of failure. Before painting any textured surface, take a piece of soft black cloth and perform a chalk test by wiping across the surface. If a heavy chalk is transferred to the cloth, then that surface is likely to be trouble. Wet a cotton ball and rub gently on the texture, if it is easily removed, then the texture is sensitive to moisture. As we've stated in previous articles, it's always wise to do a "patch test" prior to full scale production. If marginal texture is encountered, then treating the surface like a chalky exterior repaint and priming with a penetrating primer can yield good results. Check with your paint manufacturer to determine a suitable primer.
