## SOMETIMES IT'S NOT GOOD TO SHINE

By Bob Cusumano

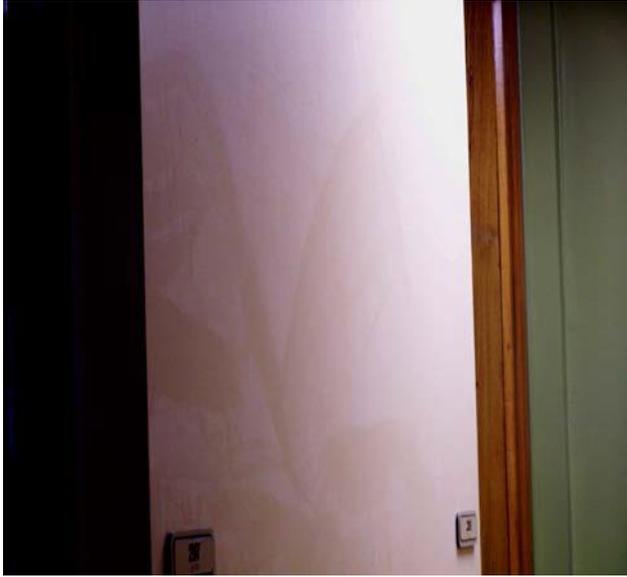
Photo 1

The work was completed and ready for the beginning of the fall semester. A few months later, it was determined by maintenance personnel that many wall areas had developed an uneven appearance. A visual inspection of several buildings confirmed that some wall surfaces had a mottled appearance as shown in photographs 1 and 2. At these locations, some wall areas appeared to be flat, while other portions were shiny. Walls in some of the building were unaffected and had an even appearance.

Based on the observations made and the testing performed, it was determined that burnishing is the cause of the mottled appearance of the paint in some buildings resulting in a difference of surface gloss. Burnishing is a term referring to glossy or shiny spots on a painted surface caused by rubbing, washing, wiping or scrubbing the surface of the paint. This causes the surface to “polish” resulting in a higher sheen than adjacent surfaces. An individual paint’s susceptibility to burnishing is based on a number of factors including amount and types of pigment, type of resin, types of colorants used, etc. Burnishing as the cause of the problem is consistent with the observation that the paint originally had an even appearance but was affected by wiping with a cloth, a situation that would develop over time as walls are subjected to cleaning.

Whenever you are using new products, particularly dark colors, it is wise to make drawdown samples. After the paint cures, rub the samples with soft cloth. If a shine develops, then be aware that a burnishing problem may result.

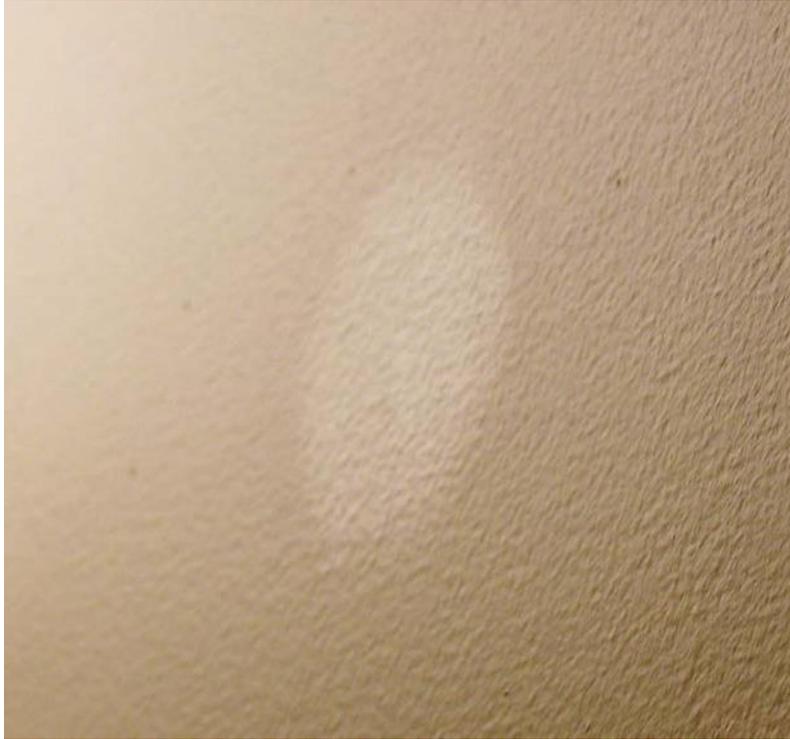
Photo 3

A black cloth was wiped on a portion of the mottled wall that appeared to be flat and photo 3 shows the result. The rubbed spot appeared to be lighter in color and more glossy than it had been originally. Microscopic examination of the cloth revealed that a small amount of material was transferred to the cloth. This procedure was repeated at similar locations with the same result.
