Coatings
Consultants
Inc.

LOOK BELOW THE SURFACE WHERE DANGER LURKS

By Bob Cusumano

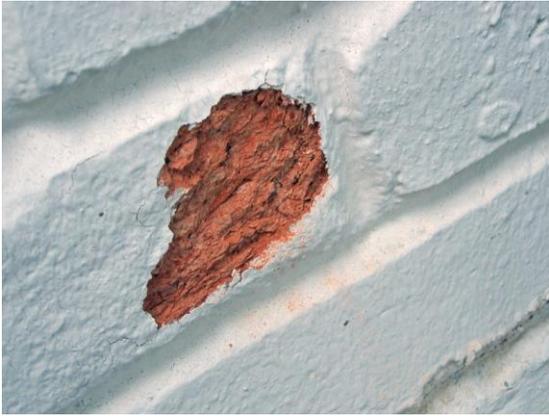
Photo 1

The Able Painting Company had the contract to paint the exterior of a two story oceanfront condominium building. The exterior walls are brick that were previously unpainted since the building was built twenty years ago. Able pressure washes the building with a chemical to remove chlorides, applies the specified masonry conditioner, and finishes the brick with a special coating designed to be applied to brick surfaces. When Able leaves the job, the building looks great. Unfortunately, a few months later the residents complain that some peeling is occurring as shown in photo 1. Adhesion tests are performed and at locations where the coating delaminates, the rear of the delaminated material is examined. In all instances, there is brick attached to the rear of the coating as shown in photo 2. The cause of the coating delamination is a cohesive failure of the brick rather than an adhesive failure of the coating to the brick. The coating adhered well to the brick, but chunks of brick have easily broken off. Fortunately, the adhesion tests indicate that areas where the brick is spalling are isolated and that adhesion is good at adjacent locations. Therefore, a spot fix is appropriate. All loose brick material must be scraped off. In some instances, this may result in an abrupt profile change requiring the brick to be resurfaced. Repair of the brick itself was not included in Able’s scope of work.

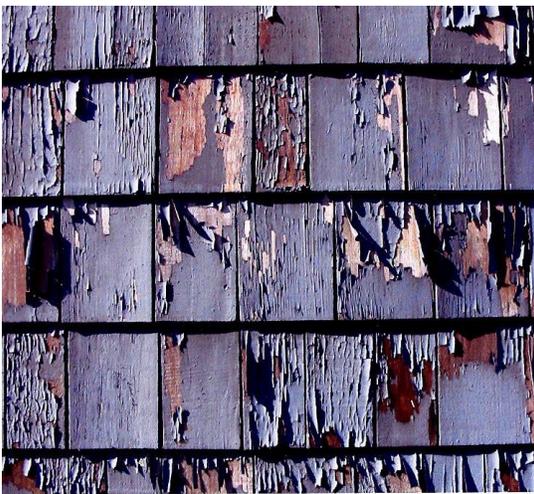
Photo 3

Best Painting Service spray-applied one coat of a fast drying exterior primer and two coats of acrylic satin house paint to the exterior rough sawn shingles. Within weeks, extensive peeling had occurred as shown in photo 3. Examination of the rear of the peeling paint revealed that wood fibers were attached to and embedded in the paint (photo 4). The cause of the peeling was the combination of product selection and application method. Rough sawn wood, especially when weathered, has loosely attached wood fibers on the surface. The use of a slow drying primer, or “long oil”, would have extended the drying time which would encourage penetration into the wood establishing good adhesion. However, since it was a quick drying primer, then the act of spray applying would have compromised the adhesion. When a fast drying primer is sprayed, it tends to lay on the surface to which it is applied. The mechanical action of brushing or rolling tends to work the primer into the surface of the wood establishing better adhesion. The two finish coats of acrylic paint exert a large amount of surface stress upon the primer and the peeling resulted.

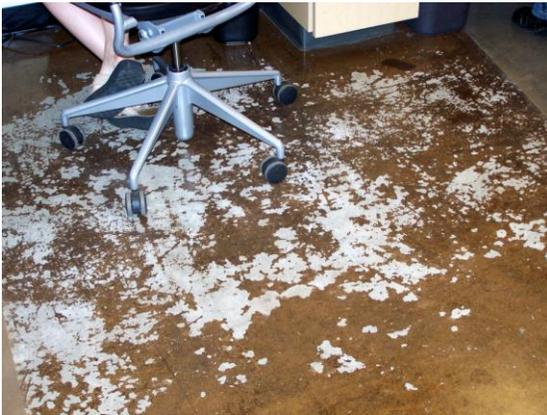
Photo 5

Dedicated Coatings Inc. painted a new car showroom facility. The concrete floors were acid etched and a concrete stain and sealer system was applied. Soon after the facility was put into operation, there was extensive delamination of the stain as shown in photo 5. Several adhesion pull tests were performed. The test results showed that the stain was well adhered to the surface of the concrete, but when failure occurred, some of the concrete was attached to the rear of the stain (photo 6).

Laitance is a thin layer of new concrete that consists of fine particles at the surface due to the upward migration of water during the placement and curing process. This concrete layer is of low strength and should be removed when surface preparation is performed. Unfortunately, the acid etching performed was not aggressive enough to remove this low strength layer. For this reason, the more aggressive method of shot blasting is often preferable.
