Coatings  
Consultants  
Inc.

## SCHOOLS TAKE COAT OFF AFTER IT SHOWERS

By Bob Cusumano

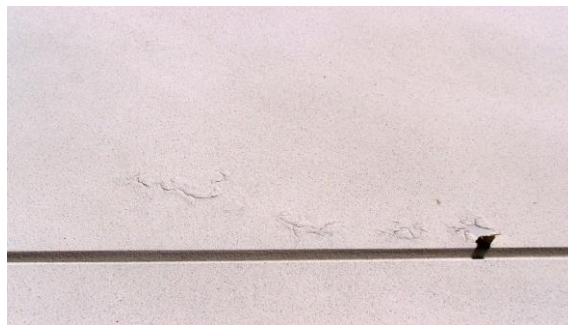
Photo 1

A site inspection of the schools revealed that there was delamination on all elevations of each classroom building and the delamination included both walls constructed of concrete block and stucco as well as tilt up concrete walls. In some instances, the delamination was localized and minor as shown in photo 1.

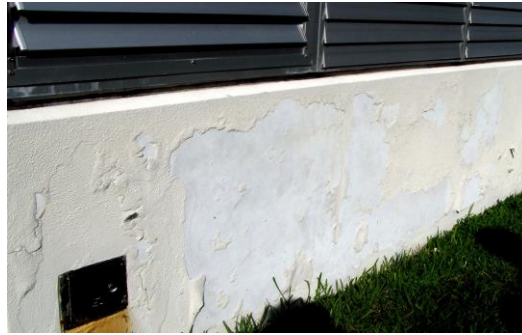
Photo 2

At other locations, the peeling was extensive as shown in photo 2.

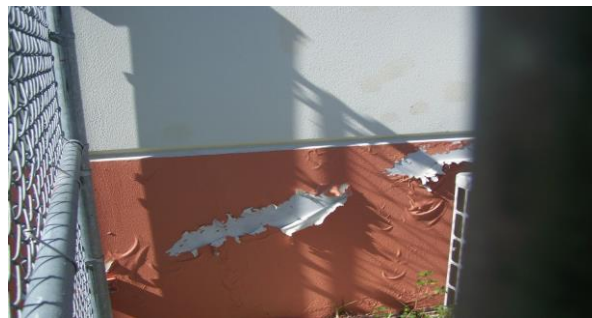
Photo 3

Delamination occurred on areas that received the primer and texture, as well as where the texture had been overcoated with the accent acrylic (photo 3). In all instances where delamination occurred, the primer remained intact on the wall. Only the textured coat and the texture coat plus accent acrylic had peeled.

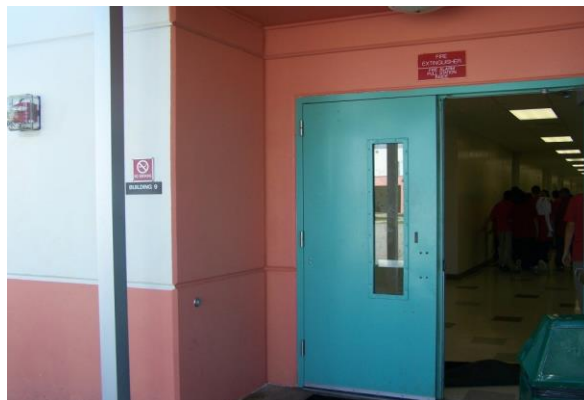
Photo 4

Exterior walls which were protected by overhangs had no peeling visible as shown in photo 4.

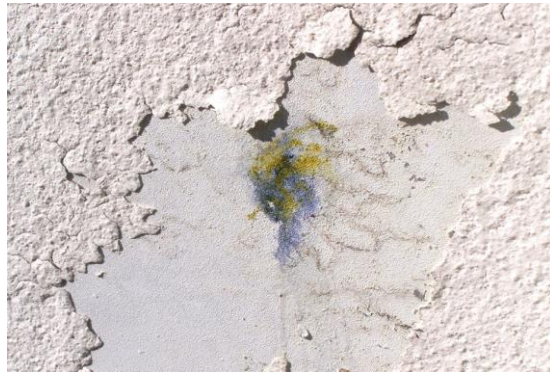
Photo 5

The pH on the surface of the primer from where coating delaminated was also determined. pH is a measure of the acidity or alkalinity of a substance. A pH of 7 indicates neutrality. pH readings decreasing from 7 indicate increasingly acidic conditions. Likewise, pH readings increasing from 7 indicate increasingly alkaline conditions. The pH on the surface of the exposed primer was measured by marking the area with a pH pencil, moistening the area with distilled water, and comparing the color to the pH chart in photo 5. The pH on the surface of the primer was found to vary from location to location. While at some places it was highly alkaline with a pH of 12, at other spots it was nearly neutral with a pH of 8.

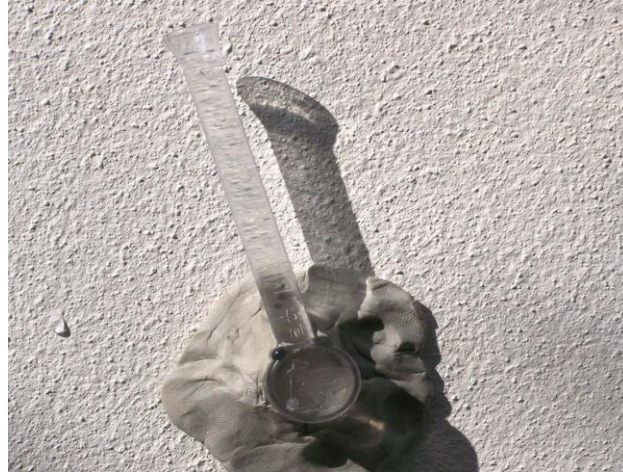
Photo 6

Rilem tubes are plastic cylinders with graduated marking that are used to measure water penetration over a period of time. In this instance, they were used to assess the water sensitivity of the textured coating that had been applied. Several locations were selected where adhesion tests indicated that the coating was well adhered. Rilem tubes were attached with a special putty and filled with water as shown in photo 6.

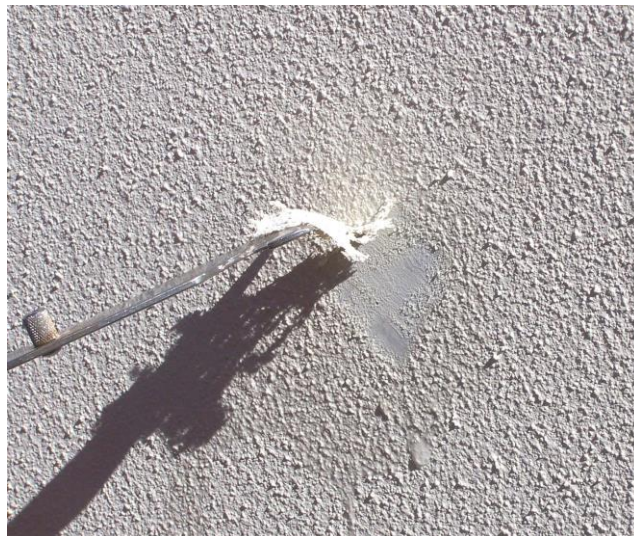
Photo 7

After 30 minutes of exposure, the Rilem tubes were removed, the surface was dried with a cloth, and adhesion by knife tests were performed. In all instances, the adhesion became very poor and the textured coating easily separated from the primer when lifted with the knife blade as seen in photo 7.

Based on our observations and the tests conducted, it was shown that the cause of the delamination on these schools is that the textured coating absorbs water which causes it to lose adhesion. Although the Rilem tests show that the coating was softened regardless

of the thickness, the delamination occurred at areas where the coating was thicker due to the thicker coating retaining moisture for a greater period of time and the fact that the additional weight and stress of the thicker coating would exceed the adhesive strength and result in delamination. At locations where the accent acrylic was applied over the textured coating, "tight" film of the topcoat retards moisture evaporation and would exert a high degree of stress to the underlying textured coating. Unfortunately, there is not a topical remedy for this condition. Therefore, the defective coating must be removed and replaced with a coating that is not water sensitive and whose adhesion will not be compromised when it gets wet.
