Coatings  
Consultants  
Inc.

## SOMETIMES YOU HAVE TO LOOK DEEP TO FIND THE ANSWER

By Bob Cusumano

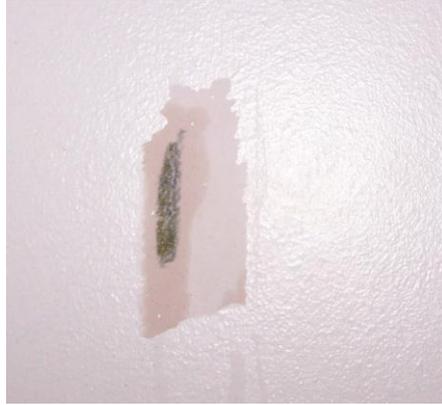
The adhesion of the paint to its plaster substrate was tested in general accordance with ASTM D3359, Adhesion by Tape Test, Method A. Incisions were made through the coating in an X pattern. Permacell adhesive tape was firmly applied to the area and then sharply removed. The adhesion of the coating was then evaluated by the amount of material that is removed. The adhesion tests yielded poor results on all of the samples using acrylic primers. Photo 1 shows a typical test result where the paint was removed under the entire area of the tape. The results were somewhat better when alkyd primers were used; however, when these primers received the acrylic finish coats, the results were again poor.

pH is a measure of the acidity or alkalinity of a substance. A pH of 7 indicates neutrality. pH readings decreasing from 7 indicate increasingly acidic conditions. Likewise, pH readings increasing from 7 indicate increasingly alkaline conditions. The pH on the surface of the plaster was measured by marking the area with a pH pencil, moistening the area with distilled water, and comparing the color to the pH chart. The pH of the bare plaster was found to be in the range of 8 to 9, which is not highly alkaline. pH tests were also conducted on the plaster exposed during the adhesion tests (also shown in photo 1) and were found to be only slightly alkaline.

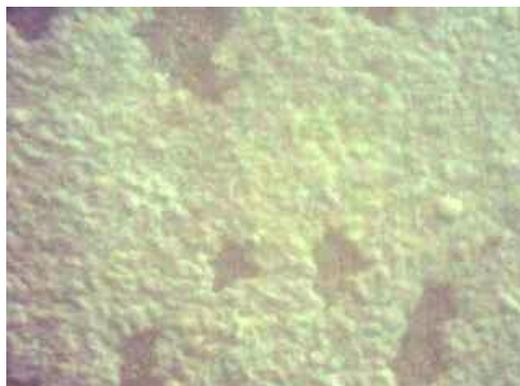
Photo 2

All of the adhesion test samples were optically examined using a stereo zoom microscope. It was observed that there was a thin layer of plaster attached to the rear of the delaminated paint in all instances. Adhesion tests were then conducted on unpainted plaster surfaces. Again, a thin layer of plaster was removed with the tape as shown in photo 2.

paint only was then measured in the same manner. The thickness of the plaster was determined by subtracting the thickness of the paint only from the thickness of the paint and plaster for each sample. The thickness of the plaster layer attached to the rear of the paint extracted during adhesion tests ranged from 0.9 to 4.5 mils.

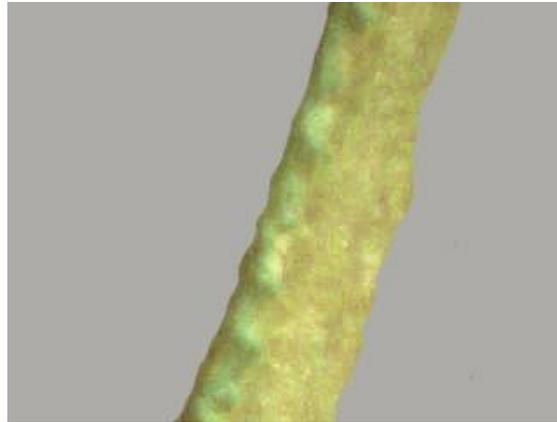
A drop of green food dye was placed on the rear of an adhesion test sample. The dye penetrated through the porous plaster and stopped at the paint interface. Photo 3 shows a cross section of the sample where both the plaster layer and coating layer are easily discernable.

Contrary to the original theory, the cause of the paint delamination at this project is not due to poor paint adhesion. The testing performed indicates that the paint has adhered to the surface of the plaster, but that the delamination is occurring beneath the paint/plaster interface, within the plaster itself. When stress is applied, the plaster fractures. This failure is a cohesive failure of the plaster. Perusal of the data sheets for the hardcote plaster used to achieve the class 5 finish indicates that the product is designed to be applied at a thickness of only 3/32 of an inch. It was determined that on this project, the plaster thickness was far greater, perhaps being a factor in the lack of cohesion displayed. Rather than jumping to conclusions regarding the cause of paint delamination, it is often necessary to look deep below the surface being painted, to determine the cause of the failure.
