# Coatings Consultants Inc.

## UNSTICKY SITUATIONS

By Bob Cusumano

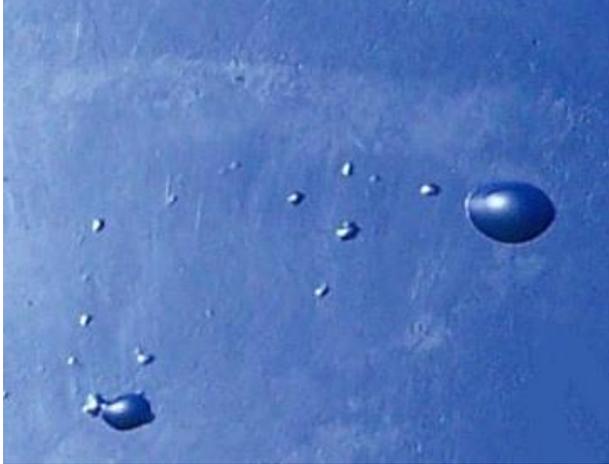
Photo 1

Before the job was accepted by the owner, some blisters began to appear as shown in photo 1. Several blisters were cut open and no water was found inside of them. However, in all instances, there was a layer of patching compound adhered to the rear side of the paint. This is visible in photo 2. Several adhesion tests were then performed. Wherever there was patch under the coating, the test results were poor. At locations where the entire paint system was applied directly to the concrete, the adhesion was good.

The cause of the blistering was a cohesive failure of the patching material, that is, the failure occurred within the patching material itself. Concrete retains a high level of moisture after its placement. When the heat of the sun strikes the dark colored coating, then the moisture migrates outward. Since the coating system was relatively thick with a "tight" film since it was a high build semi-gloss, moisture could not easily escape and blisters formed where the patching material sheared. Had a coating sample been applied over the patching material and adhesion tests performed, it would have been discovered that the patch was friable. At that point, an acrylic resin hardener might have given the patch sufficient cohesive strength and solved the problem. In this case, another contractor's problem became one for the painting contractor.

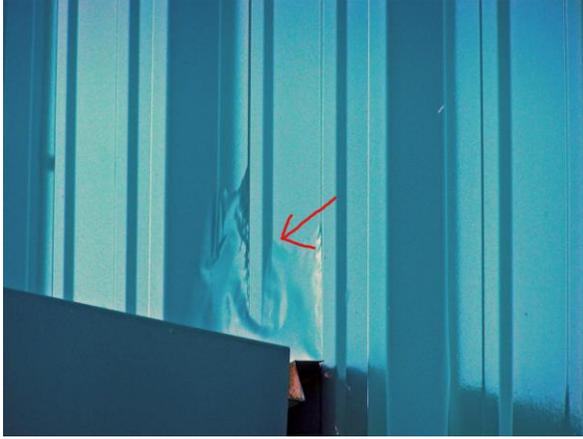
Photo 3

An elementary school was built with large areas of metal siding and fascia. The metal had a twenty year factory finish of Kynar coating. During construction, the finish on the siding was scratched at many locations and the responsible contractor touched up the damaged areas with a paint that was matched to the original color. However, since the touchup paint was not a Kynar coating, within two years it had chalked and faded leaving unsightly spots all over the siding. Specifications were written and a painting contractor was hired to pressure wash, apply a coat of bonding primer and DTM acrylic to the metal siding. Within six months after completion of the painting, several areas began to spontaneously delaminate and blister as shown in photo 3. Cross hatch adhesion tests were performed and poor results were obtained as shown in photo 4 where the failed coating exceeded the area that had been cut.

The cause of the delamination and blistered coating was the selection of the primer. Factory applied Kynar coatings are extremely hard and slick and the primer used in repainting must establish excellent adhesion. The adhesion tests performed indicate that the waterborne primer used did not establish substantial adhesion on the Kynar. Initially, the painting contractor was blamed because the data sheet indicated that glossy surfaces should be sanded, even though impractical on metal siding of this configuration and magnitude. However, testing showed that the adhesion was poor even after the factory coated surface was sanded. If the painting contractor had painted a small sample area and performed adhesion tests, the poor adhesion would have been discovered and the change to another primer would have prevented this widespread failure.

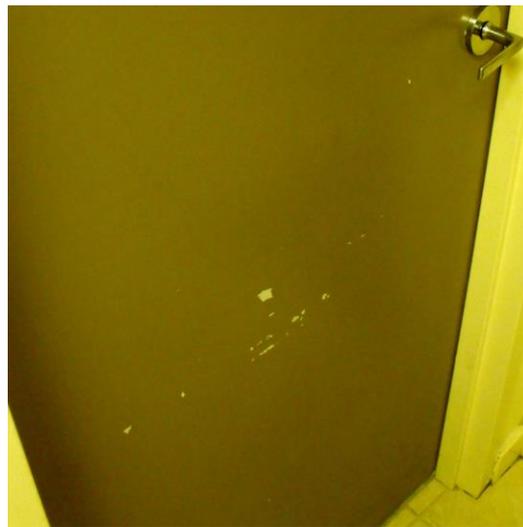
Photo 5

In the last case, a contractor signed a contract with a high-rise condominium to perform various remodeling services including painting the interior entrance doors to all units. There were formal specifications for the project written by a third party which indicated that wood doors were to be lightly sanded, dusted, and painted with two coats of gold colored latex semi-gloss enamel. Before the project was completed, some chipping and peeling of the paint occurred on the doors as shown in photo 5.

Adhesion testing was performed which indicated that the paint coats applied by the contractor are well adhered to the paint that was previously applied to the doors. However, delamination failure occurs when previously applied gray latex paint disbonds from previously applied gray alkyd paint. Alkyd paints have very different properties than latex paints. Alkyd paints form very hard, brittle films, whereas latex paints have softer, more elastic films. Latex paints tend to lay on the surface to which they are applied without penetrating. Therefore, when latex paint is applied over a hard alkyd paint film, the surface must be scarified to provide some mechanical adhesion to aid with adhesion. A bonding primer should also be used.

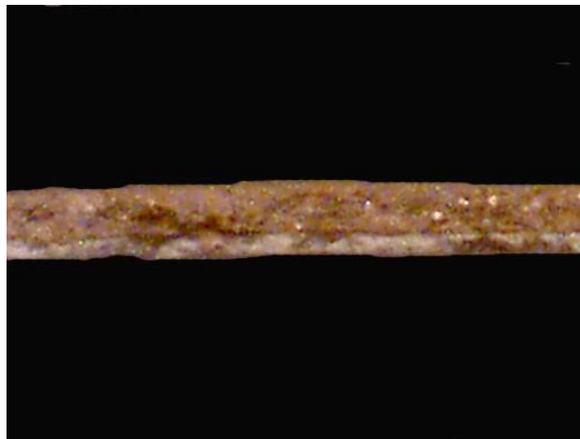
Unfortunately, when the existing gray alkyd paint was over coated with the gray latex paint, the surface was neither sanded nor a bonding primer used. However, when only one thin coat of gray latex paint was applied to the doors, very little spontaneous delamination occurred because the stress of the applied paint was minimal. However, when our contractor applied approximately four mils of additional primer and gold colored latex paint, the applied weight and stress increased greatly and the previously applied gray latex paint delaminated from the existing gray alkyd paint. Photo 6 is a photomicrograph showing the cross section of the delaminated paint. The two coats of gold paint are visible over the single coat of gray latex that delaminated.

The project specifications stated "Clean surfaces of all dirt, dust, or other contaminants that affect adhesion of paint". Clearly, this was accomplished as the paint applied by the contractor adhered well to the existing paint to which it was applied. The problem is that the previous party that applied the gray latex paint over the gray alkyd paint did not sand the alkyd paint to establish good adhesion and did not use a bonding primer. This condition should have been recognized by the author of the specifications by performing adhesion tests. Had that been done, then stripping of the existing top coat of paint would have been specified. Unfortunately, there is no topical solution to this problem. That is, any poorly and marginally adhered gray latex paint and the gold latex applied over it must be stripped before the surfaces are repainted. Here again, even though the failure is not the painting contractor's fault, the contractor becomes involved with the problem. Had a sample door been painted and adhesion tested, this problem would have been recognized before all four hundred doors were painted.
