THE RAILINGS THAT DIDN'T AGE GRACEFULLY

By Bob Cusumano

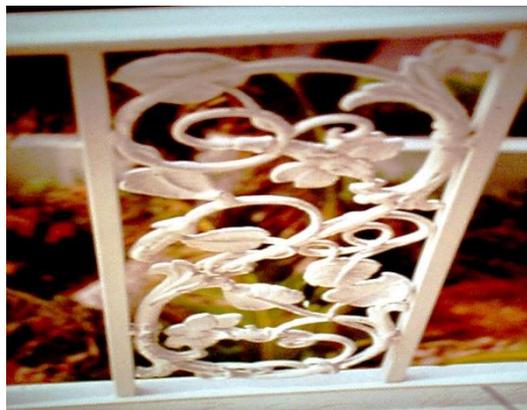
Photo 1

Upon visiting the site, we noted that the railings consisted of wrought aluminum uprights and horizontal rails to which cast aluminum decorative panels had been welded (photo #1).

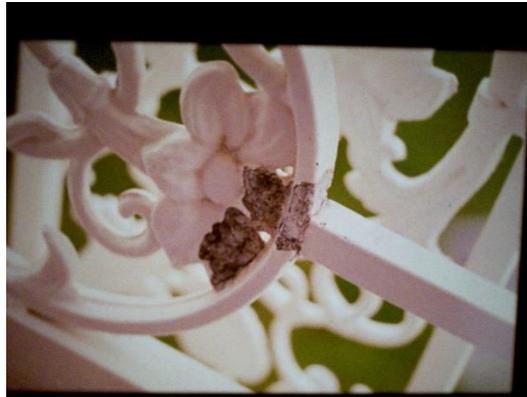
Photo 2

After examining several areas, it was determined that the decorative cast panels had widespread paint delamination and were severely corroding. In fact, so much so, that in several instances the metal could be crushed and broken with your bare hands. There was a white powder present beneath the delaminating paint, later analyzed to consist primarily of aluminum oxide, a common corrosion product and the metal rough and discolored as shown in photo #2. It was also noted that the adjacent wrought aluminum rails had blisters in the paint. When the blisters were broken, the aluminum beneath was bright and shiny with no evidence of corrosion or the white aluminum oxide powder.

This combination of observations suggested that galvanic corrosion was occurring. Galvanic corrosion occurs when two different metals are physically or electrically connected and are placed in an electrolyte, that is a liquid that is capable of carrying an electric current. Batteries are based on this scientific phenomenon. Based on their metallurgical properties, one of the metals will be less "noble" than the other and will become the anode. Corrosion and consumption of the metal occurs at the anode. The other, more "noble" metal becomes the cathode. At the cathode, no corrosion occurs. Instead, the chemical reaction that takes place causes hydrogen gas to form.

In our instance, it appeared that the cast decorative aluminum panels were the anodes and the wrought uprights and rails were the cathodes. The moist, marine atmosphere present at this south Florida location served as the electrolyte. The fact that the panels were welded to the rails and uprights put them in electrical continuity with each other, so galvanic corrosion was indeed possible.

This explained the reason why the corrosion was occurring, but did not explain its severity. Since all of the metal components were aluminum, there would only be a slight metallurgical difference between the wrought rails and uprights and the cast panels. Yet, the severe corrosion experienced suggested that additional factors came into play. It was decided that a trip to the aluminum shop where the railings had been stripped and repainted might prove productive. Indeed, it did.

Most aluminum alloys contain traces of other metals to improve their physical properties. Usually, these metals are evenly distributed throughout the metal. Metals consist of individual grains, which are usually of microscopic size. One exception is bright galvanizing, where the individual grains of zinc are easily seen. In our case, the aluminum panels contained copper. When subjected to prolonged heat followed by natural cooling, a process known as aging can occur. During aging, the copper migrated from within the individual grains to the grain boundaries. This caused each individual metal grain to become a galvanic cell with the resultant metal oxidation being called intergranular corrosion. In this case the temperatures achieved and the time of exposure was sufficient to result in aging and explained the catastrophic destruction of the panels.

The remedy was an expensive one and unfortunately cost the contractor a bundle. All of the decorative panels were cut out of the railings and discarded. New panels of a particular composition were ordered. The new panels had tabs for fastening them to the rails rather than being welded. It was important to electrically isolate the panels from the rails so that galvanic corrosion would not again occur. To accomplish this, a stainless steel screw was encased in a teflon sleeves containing a built in washer at each end. This assembly was passed through a hole in each tab. When the nut was tightened, the screw and nut were electrically isolated from the panel, with the result being that the panel and the adjacent rail were also electrically isolated. Under this condition, galvanic corrosion cannot occur. The schematic drawing shows how this was accomplished.
