TOO MUCH OF A GOOD THING CAN BE BAD

By Bob Cusumano

Golfer's Heaven is a resort retirement community in south Florida. One of the single family homeowners' associations at the complex decided to have their driveways and entrance walks at all seventy two homes re-coated. Bids were solicited and the job was let to a painting contractor who specified pressure cleaning and the application of two coats of acrylic-based concrete stain.

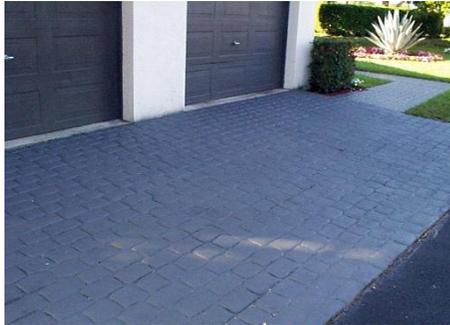
Photo 1

The sample driveways were visually examined for overall appearance and surface profile. Photos #1 and #2 show this area. The maximum difference in surface profile was measured using a pit gauge and was determined to be 40 mils.

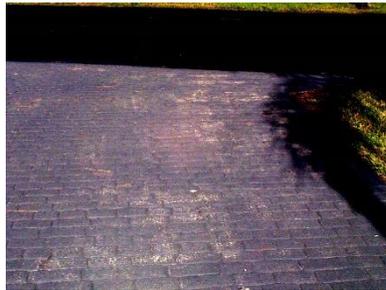
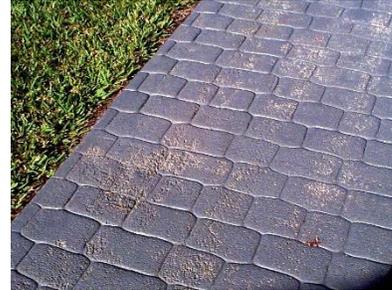
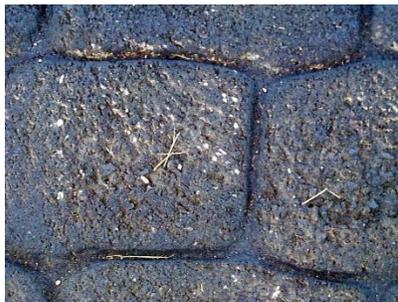
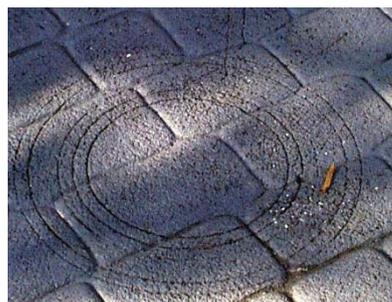
The forty additional driveways that were water-blasted were compared to the samples to determine their acceptability. Of these, it was our opinion that thirty-three were unacceptable due to substantial areas where the surface profile was deep and varied greatly. At many locations the concrete peaks created by the extreme profile were broken by contact with the tires when cars were driven on them. The maximum surface profile on these driveways varied from 180 mils to 470 mils. Twenty-nine have a profile difference of at least 240 mils, six times that of the sample driveways. An additional five water-blasted driveways had most areas resembling the sample driveways but have isolated areas where the surface profile is unacceptable. Photos #3, #4, #5 and #6 show some of the deep, variable profile created. It was our opinion that only two of the forty driveways were acceptable and resembled the sample driveways.

The painting contractor should have recognized that the profile created by the water blasting was excessive for the thin concrete stain finishing system that he was to apply. The repair would have been much less costly had the need for a concrete resurfacer been recognized prior to staining. Because it was not, the cost of the original staining and the cost of sandblasting to remove that stain prior to re-coating were extra, costly steps in the repair process.

1. The recently applied stain must be removed from all driveways considered defective. The most effective method of accomplishing this is wet abrasive blasting.

2. The next step is to apply a high strength cementitious surfacer to the water-blasted areas. This surfacer must be applied in a manner to fill the extreme porosity and texture created by the water-blasting. The surface profile created must resemble that of adjacent areas.

3. Finally, the resurfaced areas must be coated with two coats of concrete stain.

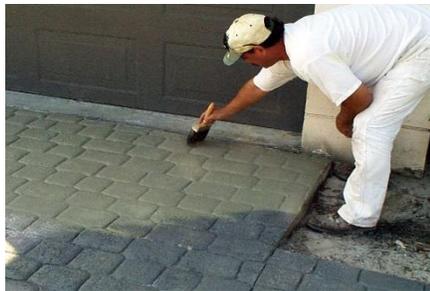
Photo 7

Because the re-surfacing operation is very labor intensive (photo #7), the total cost of repair exceeded the original cost of the water-blasting and staining.
