Coatings Consultants Inc.

WATER, WATER EVERYWHERE

By Bob Cusumano

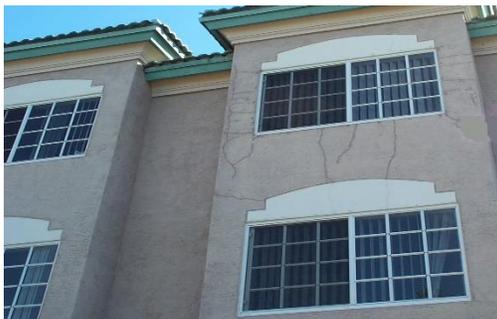
Photo 1

A Florida painting contractor was the successful bidder on a new apartment complex. The project consisted of 18 two and three story buildings, with the exteriors constructed principally of cement plaster or stucco (photo #1). The project was completed without incident. Within the first year, the owner/developer of the project began receiving complaints from several tenants concerning water intrusion into the apartments. A consulting firm made a site inspection and then the fur started flying. Several subcontractors that had worked on the project were sued, including the painting contractor. The allegations against the painting contractor included defective workmanship resulting in an unacceptable appearance, failure to apply the specified paint coats, thus allowing water infiltration through the stucco walls, and failure to apply caulking to adequately waterproof the buildings. Several hundred thousand dollars in damages was alleged. The painting contractor's insurance company became involved in the case and contacted our firm for consultation.

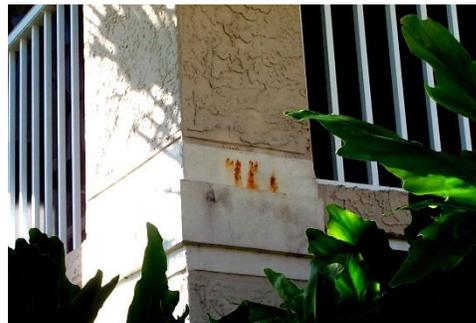
Photo 2

Upon visiting the project, it was apparent that there indeed had been extensive water intrusion. Many areas of the building had visible indications such as efflorescence, alkali burn and rusting of metal stucco accessories (photo #2).

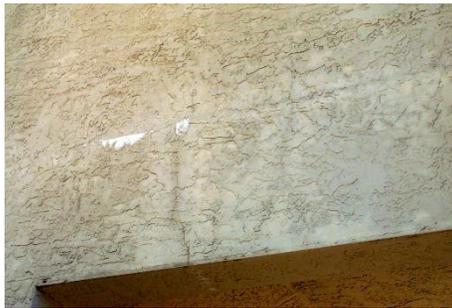
Photo 3

Efflorescence is the formation of crystalline salt deposits on a surface due to the migration of water through a cementitious substrate like stucco, concrete, or block. The vertical rundown pattern obvious in the photo #3 is typical of this condition. In some instances, this will cause the paint to delaminate, however when the affected paint film is very permeable, or when voids exist in the coating film, then the occurrence of efflorescence does not cause delamination of the paint.

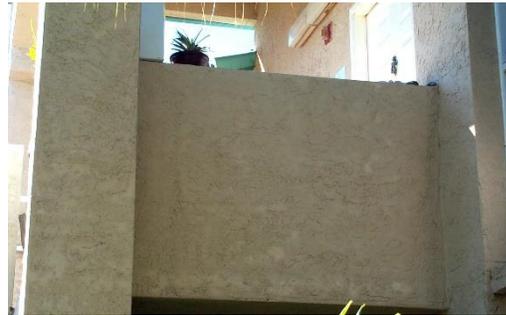
Photo 4

All cementitious materials have alkali present. When moisture migrates through the stucco, the alkali salts concentrate immediately beneath the paint film. This condition results in a degradation of the resin and/or pigment in the paint film and occurs when the paint is in contact with an alkaline substrate. Alkali burn occurs when the resin and/or pigment in the paint degrade and "bleach out". The affected area has a blotchy, mottled appearance (photo #4).

A pH survey was conducted on the buildings. It was found that at areas where the paint was mottled and discolored, the stucco immediately beneath the paint was highly alkaline, being in the range of 11 through 13. At other areas where the paint was not discolored, the pH was in the expected range of 8 to 10. This indicates that the discoloration of the paint is indeed due to alkali burn caused by water intrusion, rather than a defect in the paint itself.

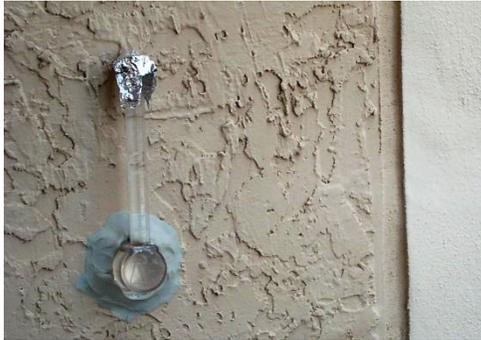
Photo 5

Next, the tendency for the painted stucco to absorb water was tested. Rilem tubes, clear plastic tubes with graduated volumetric markings, were attached to the buildings using a special putty (photo #5). The Rilem tubes were filled with distilled water and the time of the day was noted. A piece of plastic wrap was placed over each container so that the water could not evaporate nor could water enter by rainfall or from the sprinkler system. The amount of water that had

penetrated from the Rilem tubes into the wall was recorded after specific time interval and the absorption rates were calculated. All absorption rates on stucco surfaces where no cracks were present were found to be extremely low and at locations where stucco cracks were present, were found to be high. These tests proved that the water is not penetrating through the painted stucco but is instead intruding through defects in the exterior building envelope.

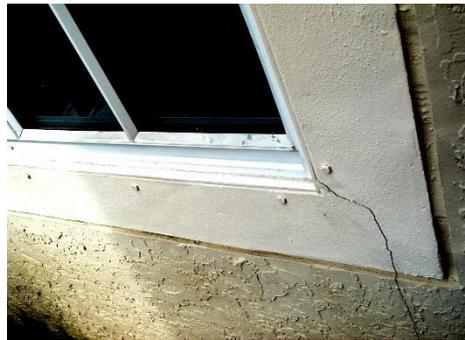
Photo 6

The caulking at the perimeter of doors and windows was examined and although some crazing was evident, there was no adhesive failure or splitting that would allow water penetration. The water intrusion experienced at these locations could instead be readily attributed to stucco cracks adjacent to the windows such as shown in photograph #6.

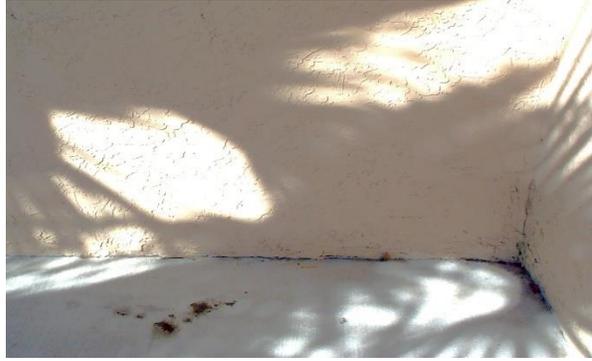
Photo 7

That's because even though the painting contractor's estimate only priced out caulking the perimeter of exterior doors and windows, there was a caulking section in the specifications that indicated that additional locations needed to be caulked including all junctures of dissimilar materials, all building penetrations, and all 90 degree junctures. Further, the painting contractor signed a contract indicating that all painting work and related caulking would be performed. Unfortunately, this vague term caused the painting contractor to assume some liability for water intrusion. For example, as shown in photo #7, water would puddle on some concrete floors. Since the wall to floor intersections had not been caulked, water could penetrate into the buildings.
