Coatings Consultants Inc.

MAKE SURE IT STICKS

By Bob Cusumano

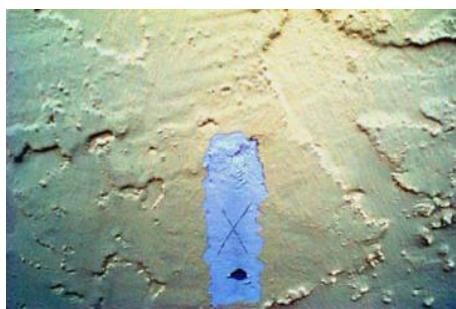
Photo 1

If you're in doubt about adhesion, do a patch test. IF YOU'RE IN DOUBT ABOUT ADHESION, DO A PATCH TEST. I'm sorry that I had to shout at you, but I did it for your own good. I see so many cases of paint delamination that could have been predicted and avoided had patch samples been applied and then adhesion tests performed. This procedure involves preparing and applying all of the specified coats to a selected area of the surface to be tested. The same preparation and application equipment you intend to use for the actual job should be used. The manufacturer's recommended drying time and coating thickness should be observed. After proper cure, the adhesion can be assessed by performing an adhesion by tape test as described in ASTM standard test method D3359. In general, cuts are made through the coating in an X or grid pattern. A pressure sensitive tape is applied over the cut and then rapidly removed. The amount of coating removed with the tape is an indication of the adhesion. Photo #1 shows a poor result on a painted stucco wall. Probing with a knife blade or other sharp instrument can also be effective in testing adhesion.

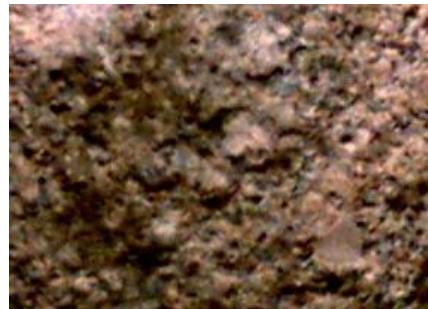
Photo 2

Laitance is a thin layer on the surface of new concrete that consists of fine particles due to the upward migration of water during the placement and curing process and often occurs on concrete floors. This concrete layer is of low strength and should be removed when surface preparation is performed. Photo #2 shows a microscopic view of laitance on the rear of delaminated paint. Efflorescence is the formation of crystalline salt deposits, usually white, on a surface due to the

migration of water through a cementitious substrate. Both laitance and efflorescence are unsuitable surfaces for painting as long term coating adhesion will be compromised.

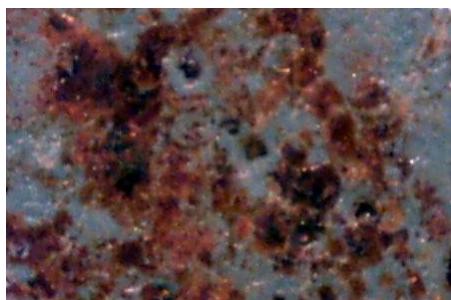
Photo 3

Painting contractors often apply finish coats to steel surfaces prepared and primed in the fabricating shop. Mill scale is an iron oxide that forms on the surface of steel as a result of fabrication and heat treatment. Initially the mill scale is tightly adhered, but as time passes, the mill scale expands at a different rate than the adjacent steel resulting in cracks. When cracks occur, moisture can penetrate allowing rust to form beneath the scale and spalling results. Rust and mill scale should be removed during surface preparation at the shop prior to priming, but if not performed properly can result in coating delamination. Photo #3 depicts rusted mill scale from the rear of delaminated paint on steel door frames.

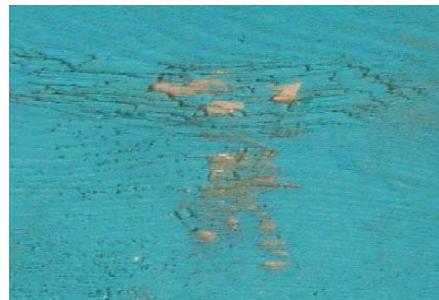
Photo 4

Rough sawn wood, especially when weathered, has loosely attached wood fibers on the surface. If a latex paint or solid stain is spray applied to this surface, then poor adhesion often results due to the paint laying on the surface and loose fibers detaching from the wood carrying the paint with it. This condition is shown in the adhesion test result in photo #4. When that same wood was painted by brush instead of sprayed (photo #5) the adhesion was improved because the paint was "worked into" the substrate.

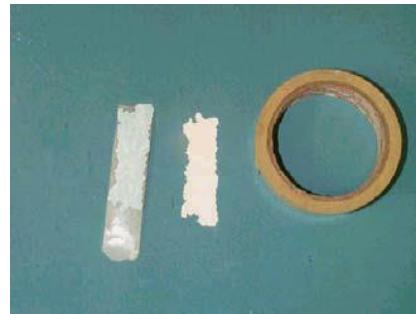
Photo 6

Probably, more gallons of paint are applied to drywall and gypsum board than any other surface and adhesion problems can even occur here. After joint compound is applied to the nail heads and joints it is often sanded to produce a smooth finish. The dust created from this operation should be removed prior to painting so that adhesion can be achieved on a sound, clean surface. Drywall texture or orange peel is sometimes applied to the surface of drywall prior to painting. If an acrylic binder is not added in sufficient quantity, then the resultant texture may have a chalky surface and low cohesive strength. Photo #6 illustrates that white texture is attached to the rear of the blue paint that delaminated during the adhesion test.

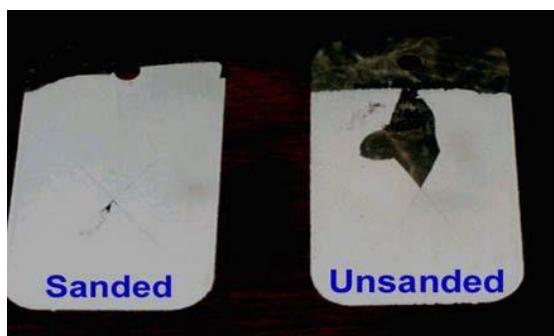
Photo 7

In repaint situations, chalk, dirt, mildew, wax, oil, salt, and other surface contaminants may interfere with the establishment of good coating adhesion and must be removed using appropriate measures. Hard, smooth surfaces should be sanded and wiped clean to promote good mechanical adhesion. Photo #7 shows that this is an effective procedure. But in repaint situations, not only does the surface being painted need to be evaluated but also the adhesion of the existing coatings. It is common that when additional coats are applied to a previously painted surface that has marginal paint adhesion, the additional weight and stress produced may cause delamination, especially when applying top of the line products.
