Coatings Consultants Inc.

THE IMPORTANCE OF ASSESSING ADHESION

By Bob Cusumano

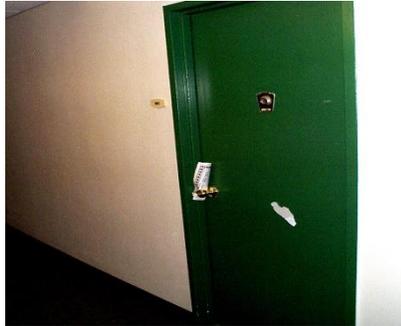
Photo 1

A short time after completion of the painting, it was noted that some doors and frames began to chip and show signs of paint delamination (photo #1). The Association contacted the contractor, expressed its concern and demanded that the situation be assessed and corrected.

The cause of this failure is insufficient surface preparation. Because of the marginal adhesion of the existing paint, it was not proper to simply lightly sand the surface and apply additional paint.

As a chain is only as strong as its weakest link, a paint system is only as strong as the weakest bond between or within individual coats. In this instance, a majority of the existing paint should have been removed to a sound surface by scraping or stripping. Although this process is tedious and costly, good paint adhesion cannot be accomplished on the existing painted surfaces unless this is accomplished. Each coat of paint over a marginally adhered coating tends to further compromise adhesion of the total applied system due to increased weight and stress.

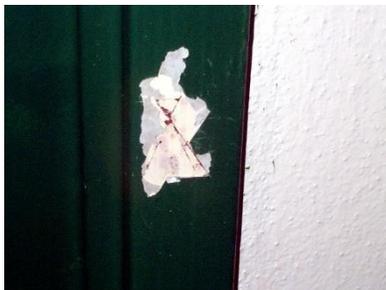
Photo 2

Adhesion tests were performed on randomly selected hollow metal doors and frames that did not exhibit any peeling or coating delamination. These were performed in general accordance with ASTM D3359, Adhesion by Tape Test, Method A. Incisions were made through the coating in an X pattern. A specified adhesive tape is firmly applied to the area and then sharply removed. The adhesion of the coating is then evaluated by the amount of paint that is removed. Photograph #2 show the typical result of the adhesion tests. A great deal of paint could be easily removed using a putty knife as illustrated in photograph #3.

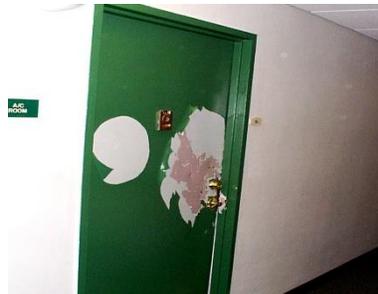
Photo 3

Paint chips removed during adhesion tests were visually examined. While the front side of the chips was green, the rear side of the paint samples was gray. This is an indication that the delamination included both the newly applied green enamel and previously applied coating. That is, the new enamel is well adhered to the previously applied gray paint, but that marginal adhesion exists between previous coats.
