AVOIDING JOINT PAIN

By Bob Cusumano

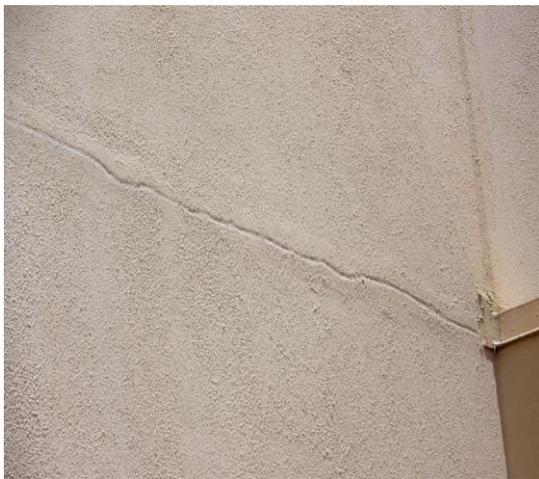
Photo 1

If you are responsible for the sealant installation, then you need to be sure to select a caulking material that has the proper physical properties for the situation at hand. When a sealant is used in joints that are subject to movement, then the amount of expansion and contraction must be considered. Certain sealant materials can accommodate joint movement of 12.5% or higher, often necessary in expansion joints. Other factors that should be considered include adhesion, hardness, abrasion resistance, effective temperature range, and resistance to weathering. The sealant shown in photo 1 suffered excessive shrinkage and created an aesthetic issue.

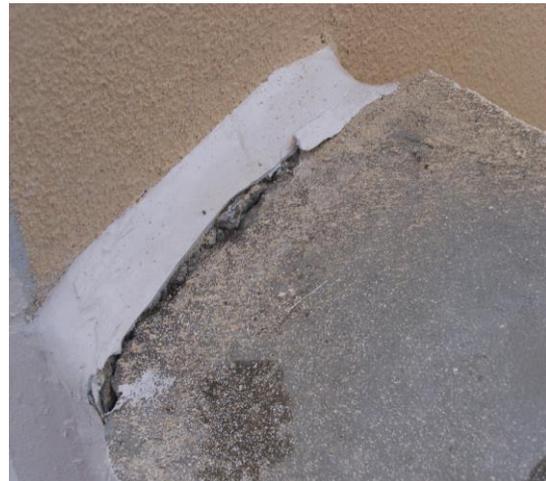
Photo 2

is clean and sound. The sealant shown in photo 2 failed because it was applied to an unsound surface whose cohesion was less than the stress applied by the sealant. Joint cleanliness is critical. In a previous article, we discussed the importance of joint design and how the depth of the joint is controlled using backer rod. Another important reason for using backer rod is to prevent a condition known as "three point adhesion". When you install caulking, it should be adhered to the two sides of the joint, but not to the rear. If the sealant is attached to both the sides and the rear of the joint, then its ability to elongate is compromised and sealant failure often occurs. The backer rod either provides a surface that the sealant will not adhere to or will be so flexible that even though the sealant adheres to it, it does allow the sealant to move properly.

There are many sealant failures due to the loss of adhesion from one of the surfaces to which the sealant is attached. The interior of the joint must be inspected to ensure that it

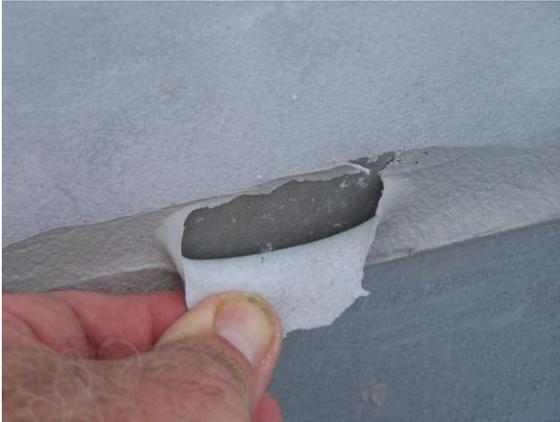
When the sealant is applied to a painted surface, then the adhesion of the paint to which the sealant will be applied must first be assessed. Photo 3 shows caulking that failed because it was applied over a primer that had poor adhesion to the concrete tilt up panels. All loose materials, including poorly or marginally adhered previously applied coats of paint, must be removed.

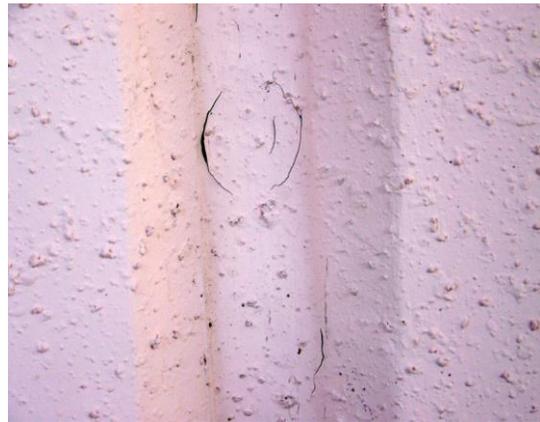
After the expansion joints are sealed, they are often finish painted with the remainder of the exterior of the building and that can present additional challenges. You need to be certain that the paint that is applied can accommodate the movement that occurs in the sealant joints. Photo 4 shows a textured coating that is beginning to crack on a sealant joint. This particular joint is protected from extreme weathering elements and has not yet shown the effects of exposure. Photo 5 shows a similar joint that is exposed, resulting in delamination of the coating.

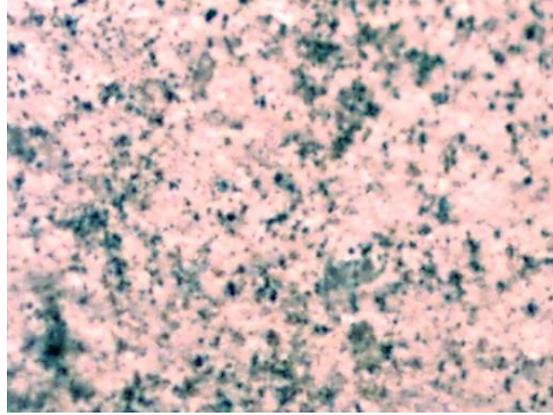
Examination of the rear of the delaminated paint shows that there can be multiple causes of marginal adhesion of the paint to the sealant that leads to ultimate disbonding. Photo 6 shows that this coating was applied over caulking that had collected a great quantity of dirt. Solvent wiping of the joint is often necessary to remove surface contaminants so that the coating can establish good adhesion to the sealant.

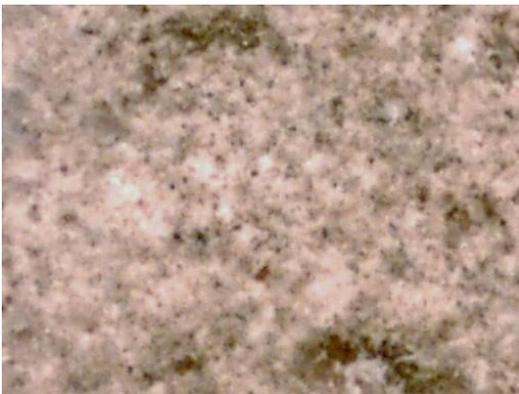
Photo 7

Before applying a coating to the joint sealant it is important to ensure that it has properly cured. The coating that delaminated in photo 7 has a thin layer of the sealant material attached to the rear of the coating film. The dark spots are dirt, but the light gray areas are traces of the sealant material. In this instance, the stress on the coating exceeded the cohesive strength of the top layer of sealant material resulting in delamination.

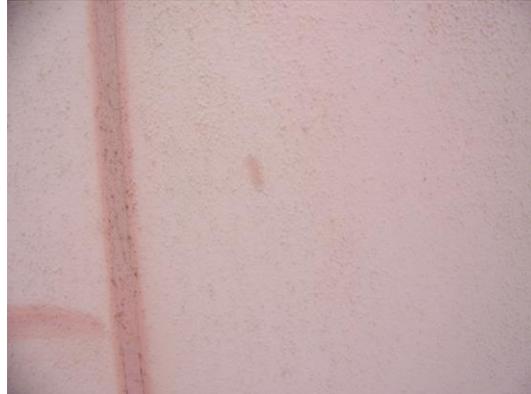
In other instances, components of the sealant, such as surfactants and plasticizers, may bleed through the applied coating and result in unsightly discoloration. Photo 8 shows

such a condition where the coating over and immediately adjacent to the caulk joint is distinctively darker than the adjacent coating.
