Coatings Consultants Inc.

SOMETIMES IT STICKS AND UNFORTUNATELY, SOMETIMES IT DOESN'T

By Bob Cusumano

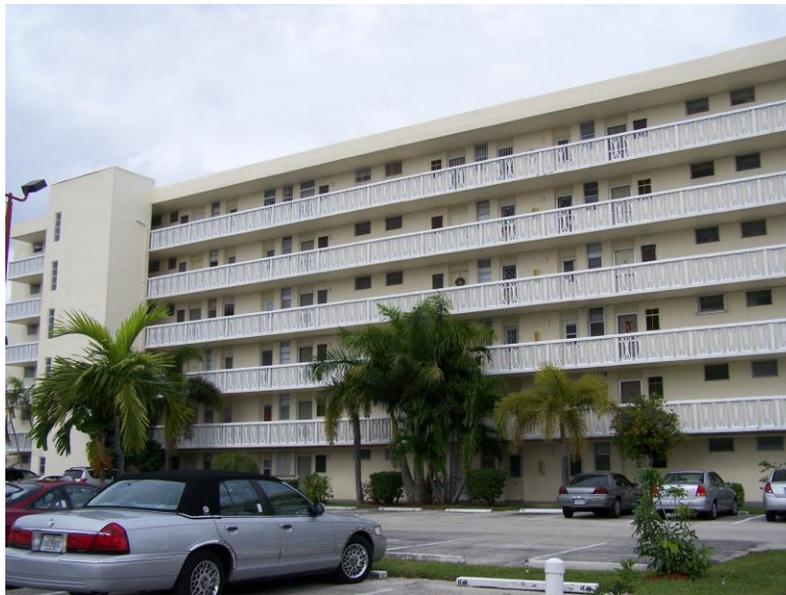
Photo 1

The Emerald Arms is a large six story condominium building shown in photo 1. Exterior concrete floors had been previously coated with silicone acrylic floor stain. The stain was in relatively good condition with some areas showing a wear pattern. The reason for refinishing the floors at this time was because the building walls had been repainted and the color of the floors did not complement the new color scheme.

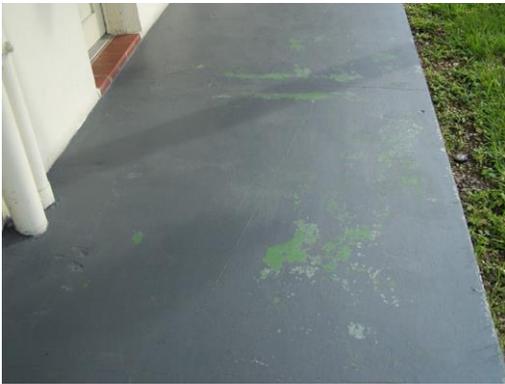
Photo 2

Observations made at the time of inspection revealed that most of the delamination occurred at areas of heavy traffic, including ground floor areas near stairs and the outer perimeter of ground floor walkways as shown in photo 2. Only a few isolated spots had failed on the upper floors of the building as shown in photo 3.

The cause of the paint delamination at the Emerald Arms was moisture migrating through the concrete walkway. The moisture could pass through the silicone acrylic stain, but was stopped at the alkyd/ stain interface. Because the moisture could not escape, delamination resulted. The moisture readings were low where the paint had peeled because the water was no longer trapped. Examination of the site indicated that there were sprinklers adjacent to ground floor walkways, a constant source of moisture. As is common, there was no vapor barrier beneath the concrete walks. pH testing on the rear of the delaminated paint chips yielded highly alkaline results, confirming moisture migration as the cause of the problem.
