Coatings Consultants Inc.

CASE DISMISSED!

By Bob Cusumano

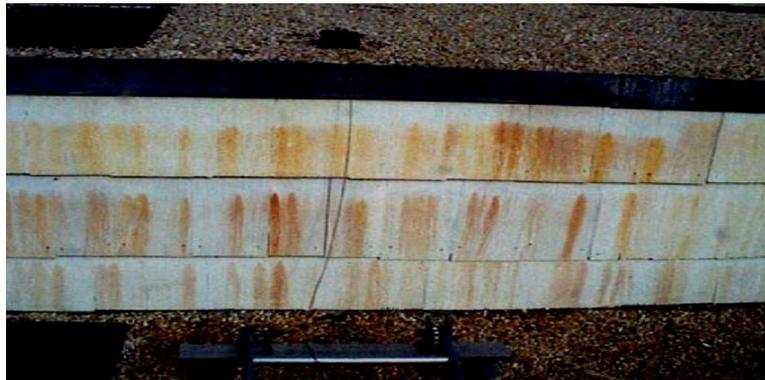
Photo 1

A painting contractor was awarded the contract to repaint 35 townhouse buildings. As a part of the contract, cement tile mansards were to be repainted white. The contractor applied a solution to kill mildew and algae, pressured cleaned the tiles to remove any surface contaminants and loose paint, primed them with an acrylic surface conditioner and finished them with a quality acrylic latex house paint. Sometime after completion of the project, the property owner called the contractor to tell him that the mansard roofs were turning orange (photo #1). "They never did this before, so it must be something that you did. Maybe its the mildewcide solution bleeding through the paint."

When the stains were analyzed they turned out to be rust stains, but where was the rust coming from? Upon asking the owner many questions about the project, it was discovered that the flat

gravel roofs on the buildings had recently been replaced. The new gravel used was then analyzed and was found to contain a high level of iron! The roofing contractor was then contacted to replace the gravel and the painting contractor was paid an extra to chemically remove the stains.

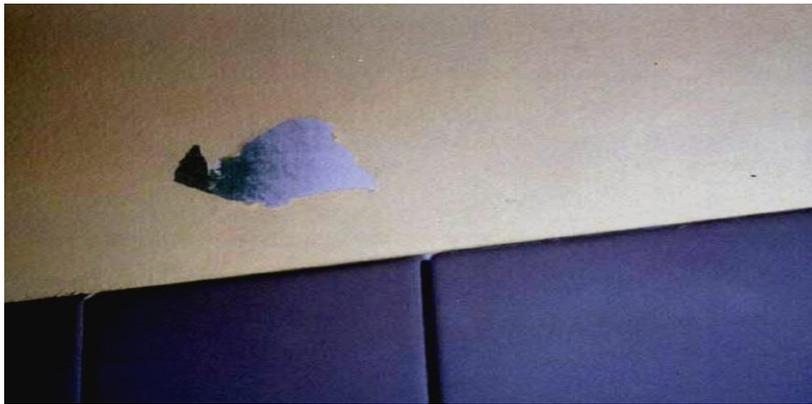
Photo 2

Two hundred new condominium units were built. The interior walls were constructed of gypsum board with an orange peel texture finish. The painting contractor then painted the walls with one coat of latex primer sealer and two coats of latex finish. The bathrooms and kitchens were finished with semi gloss and the other walls were painted with flat. After the project had been completed and residents moved in, the painting contractor was notified by the project developer that they had received many complaints regarding the interior paint. It seems that whenever residents attempted to wash smudges from the walls, the paint came off (photo #2). In some units wall paper was installed. and seams either curled or in some cases, the wall paper fell off the wall completely. The painting contractor was told that the paint had poor adhesion.

These occurrences were verified at the project, but after investigation, the problem was not the paint, it was the orange peel texture that had been applied. The texture used was simply drywall joint compound that was thinned with water so that it could be sprayed. There was no resin or binder in the texture to harden it and provide cohesion. When water was placed on the wall, it would penetrate through the latex and re-emulsify the texture. This resulted in delamination of the paint, with some dissolved texture attached to the rear side of the paint. When wallpaper was installed or the walls were otherwise stressed (such as applying masking tape), the cohesive strength of the texture was not strong enough and delamination would occur.

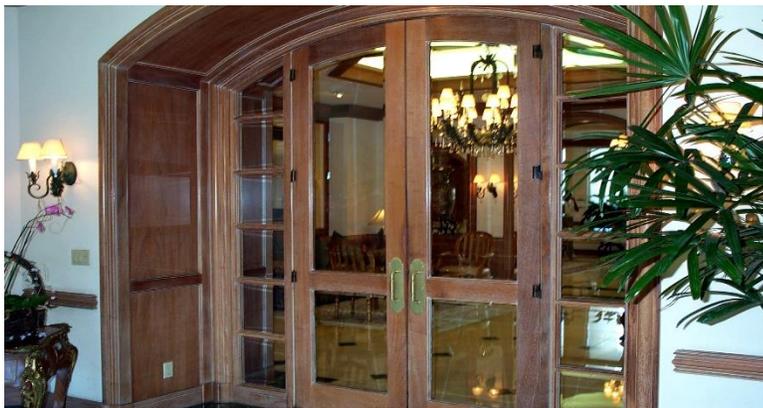
Photo 3

Examination of all of the wood at the club house revealed that indeed there was a problem. The paste wood filler, that was originally a natural wood color which blended with the mahogany had changed color and turned white (photo #3). The resultant white dots and dashes were in stark contrast to the beautiful mahogany. Stricken by the enormity of the problem, the painting contractor vowed to research the situation and report back.

Fortunately, the painting contractor retained some of the paste wood filler. When extensive testing was done it was determined that the filler contained an oil that as long as it was intact, caused the filler to be the natural color of the wood. However, if that oil thoroughly dried out, the paste wood filler turned white. Because the filler was applied directly to the bare wood, the oil would penetrate into the wood over time, causing the filler to turn white. The painting contractor was able to prove that he used all of the procedures and materials specified by the architect. He

further stated, which was proven with other samples, that an improper specification was the cause of the problem. When sanding sealer was first applied to the bare wood followed by application of the paste wood filler, then followed by the second coat of sanding sealer, the paste wood filler was sandwiched between the two coats of sanding sealer and therefore would not dry out and discolor. The painting contractor was happily cleared of wrongdoing.
