Coatings Consultants Inc.

PITFALLS OF PAINTING STUCCO

By Bob Cusumano

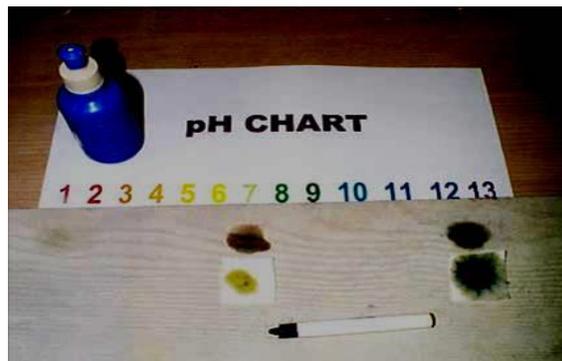
Photo 1

So how do we measure pH? Well, the most prevalent method is to use a pH pencil and distilled water. These pencils may be obtained from companies that distribute paint testing equipment. The pH on the surface of the stucco is measured by wetting the area with distilled water, stroking the moistened surface with a pH pencil, waiting approximately 30 seconds and then comparing developed the color to the pH chart provided with the pencil (photo 1). pH papers and electronic measuring devices are also available.

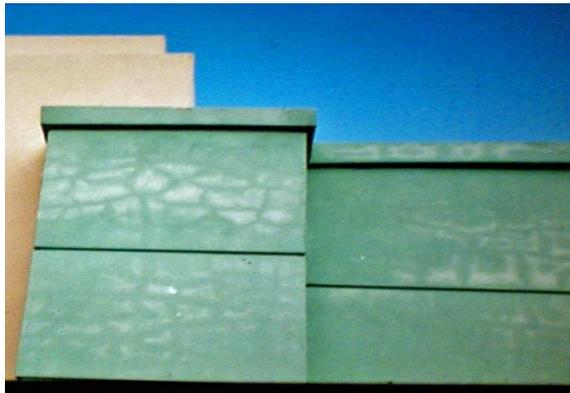
Photo 2

What happens if we paint a stucco that is too alkaline (commonly called “hot”)? Depending upon the properties of the paint used, including the type of resin and pigments employed, the paint may suffer from a condition known as alkali burn. Alkali burn occurs when the resin and or pigments in the paint degrade and "bleach out". The surface will usually have a mottled or blotchy appearance and often premature chalking occurs. This condition is shown in photo 2.

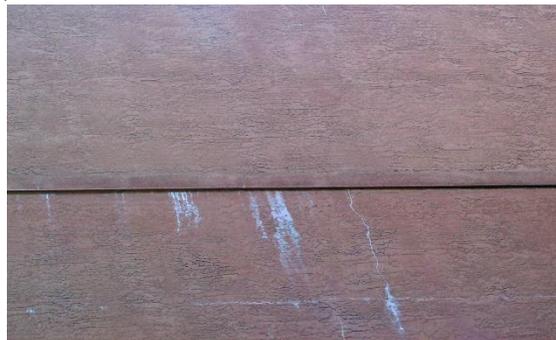
Photo 3

Two other conditions related to alkalinity and moisture may also occur. Efflorescence is the formation of crystalline salt deposits, usually white, on a surface of the paint due to the migration of water through the cementitious substrate. The vertical rundown pattern obvious in the photo 3 is typical of this condition. When the affected paint film is very permeable, or when voids exist in the coating film, then the occurrence of efflorescence does not cause delamination of the paint.

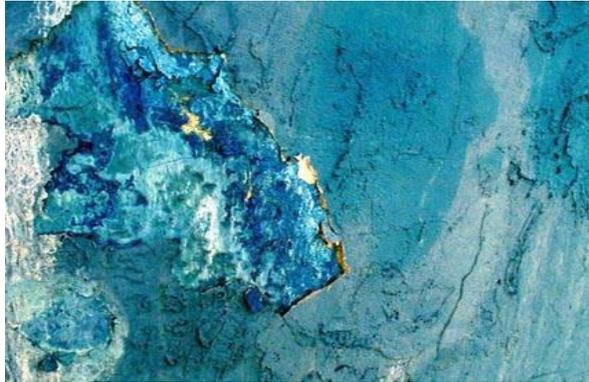
Photo 4

Saponification is the chemical degradation of a coating due to high alkalinity and moisture and occurs when the resin of the paint used is not alkali resistant. The coating resin is attacked from the rear side and loses its physical characteristics by turning into a soap-like material. Blisters usually occur which have a “mushy” consistency. When the saponified coating dries, it becomes brittle and loses its adhesion. This phenomenon is shown in photo 4.

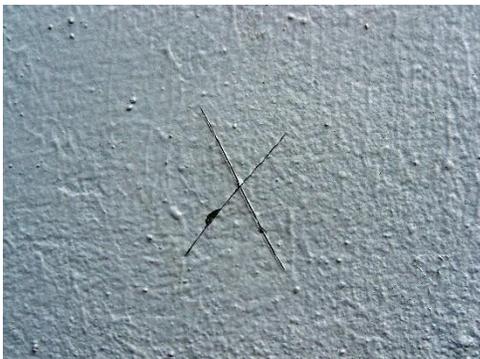
Photo 5

Just checking the surface alkalinity and moisture content of the stucco is not enough. Recently, a painting contract was painting the exterior stucco on a twenty story hotel. A high build acrylic paint was being used. Before painting, the paint manufacturer measured the surface pH of the stucco and found it to be approximately 9 at all locations. The painting contractor measured the moisture content with a moisture meter and found it to be very low, so he proceeded to paint the exterior walls. Within a few weeks, certain parts of the wall began to exhibit peeling paint. Those of you who are regular readers of this column know that I stress the important of adhesion tests ad nauseum. Well, here’s another example of why I do. Adhesion tests should yield results similar to that shown in photo 5. Unfortunately, more than half of the adhesion tests performed on this building had results similar to those depicted in photo 6. Note that there is a thin layer of stucco attached to the rear of the delaminated paint. In this instance, an unstable stucco substrate is the cause of the coating delamination. Even though the surface pH and moisture content of the stucco were proper, the surface in many places was soft and friable rather than hard. When high build products are applied, the weight and stress created may exceed the cohesive strength of the material to which they are applied. When this occurs, the unfortunate result is peeling paint.
