# Coatings Consultants Inc.

## WHEN THOUGHTS TURN TO SPRING

By Bob Cusumano

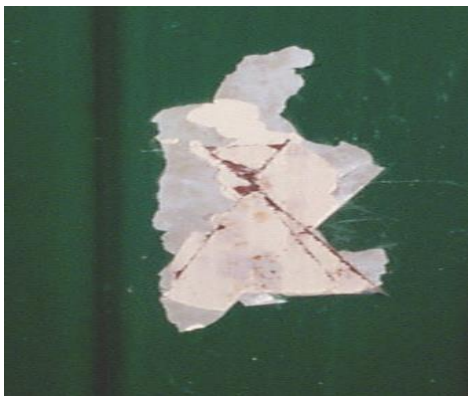
Photo 1

It is of utmost importance that we adequately assess the surfaces that we intend to repaint. Any peeling areas should be noted as requiring extra preparation. However, even if there are no visible signs of paint delamination, tests should be conducted to assure that the existing paint is not poorly or marginally adhered. For this we turn to the cross hatch adhesion test that I have previously spoken so much about. To perform this test, make an X cut with a razor blade into the substrate. Clean any contaminants off the surface and apply a strong masking tape over the X. Rub it on so that it is well adhered. Then sharply remove the tape and see what comes off. If nothing comes off, then the surface appears to be sound. If some paint layers are removed during the test and some remain on the building, then the layers removed during the test may need to be removed before repainting is performed. A second adhesion test should be performed at the same location to determine if even more previously applied paint coats are poorly adhered. If all of the paint coats are removed to expose the bare substrate, then stripping of all previously applied paint is necessary. Photo #1 shows the result of a cross hatch adhesion test where a green topcoat and gray layer beneath it have been removed exposing a white coat of paint.
