Coatings Consultants Inc.

IT PAYS TO BE PREPARED

By Bob Cusumano

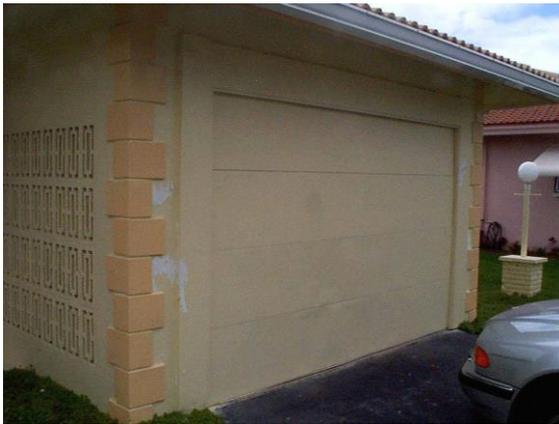
In repaint situations, you must determine the soundness of the existing paint coats. As exterior paints weather, a surface chalk often usually develops which can interfere with paint adhesion, especially when the paint that you are applying is a latex. If that surface chalk is heavy, it must be removed. If it is light, then a masonry conditioner whose function is to bind the light chalk to establish a sound surface can be used. Photo 1 shows one of four hundred and fifty houses that was in the process of being painted. About halfway through the project some peeling began to occur. When he pressured cleaned the house the second time, look at all of his paint that was removed (photo 2). The problem was that there was a very thick layer of the chalk that was not removed during surface preparation. Even though a masonry conditioner was applied it could not penetrate through the six mils of chalk on the surface. Unfortunately, this painting contractor went out of business due to this project.

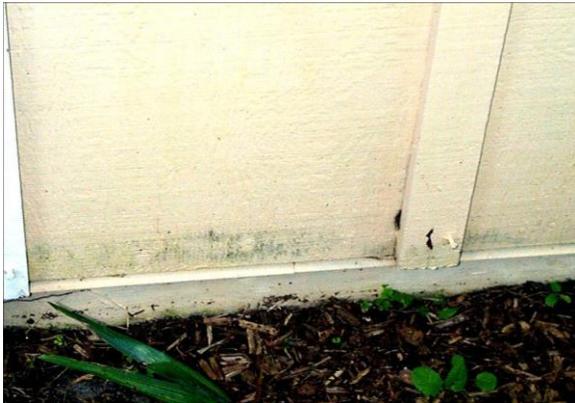
Dirt, mildew, wax, oil, salt, are other surface contaminants that may interfere with the establishment of good coating adhesion and must be removed using appropriate measures. Photo 3 shows a residence with wood siding where the contractor painted over mildew. When this occurs, the mildew continues to grow beneath the paint. The remedy is to strip the paint, kill the mildew, and repaint. It's always cheaper to do it right the first time. Photo 4 shows the result of painting over a door that had been waxed.

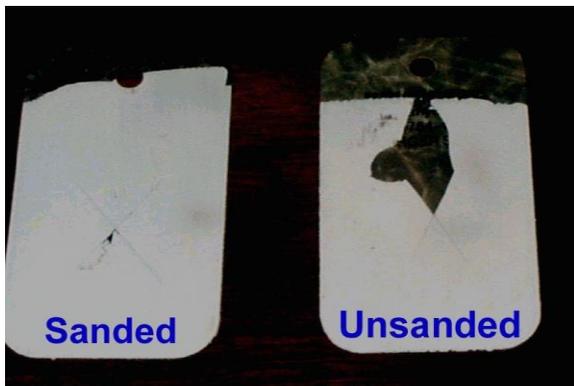
Hard, smooth surfaces should be sanded and wiped clean to de-gloss the surface and promote good mechanical adhesion. Photo 5 shows that this is an effective procedure. The shiny plastic laminate coupon on the left was sanded and wiped prior to painting. The coupon on the right was left in its natural state. Adhesion tests on each sample show that sanding and wiping increases the adhesion.

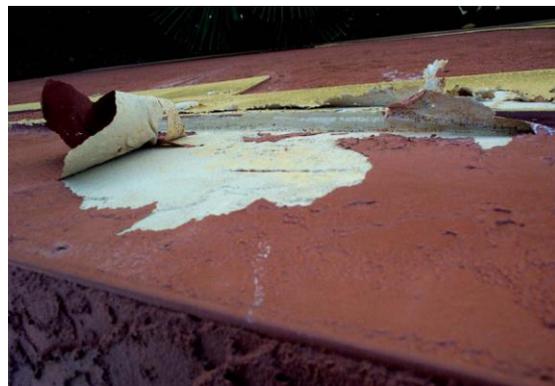
Photo 6

But in repaint situations, not only does the surface being painted need to be evaluated but also the adhesion of the existing coatings. It is common that when additional coats are applied to a previously painted surface that has marginal paint adhesion, the additional weight and stress produced may cause delamination, especially when applying top of the line products. Therefore, it's important to test the adhesion of existing coats to avoid failures like those shown in photo 6.

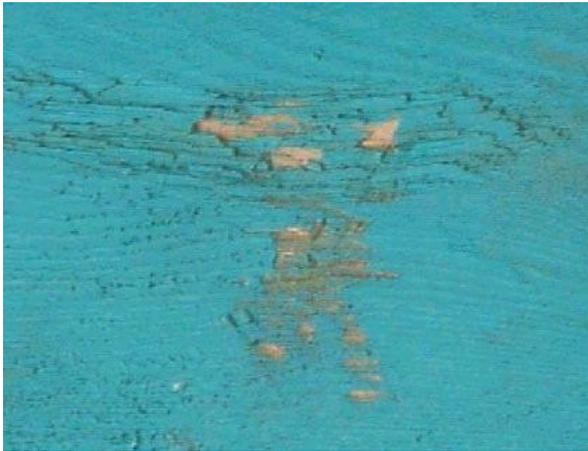
Photo 7

Now let's address some adhesion issues when painting new exterior surfaces. Rough sawn wood, especially when weathered, has loosely attached wood fibers on the surface. If a latex paint or solid stain is spray applied to this surface, then poor adhesion often results due to the paint laying on the surface and loose fibers detaching from the wood carrying the paint with it. This condition is shown in the adhesion test result in photo 7. When that same wood was painted by brush instead of sprayed (photo 8) the adhesion was improved because the paint was "worked into" the substrate.

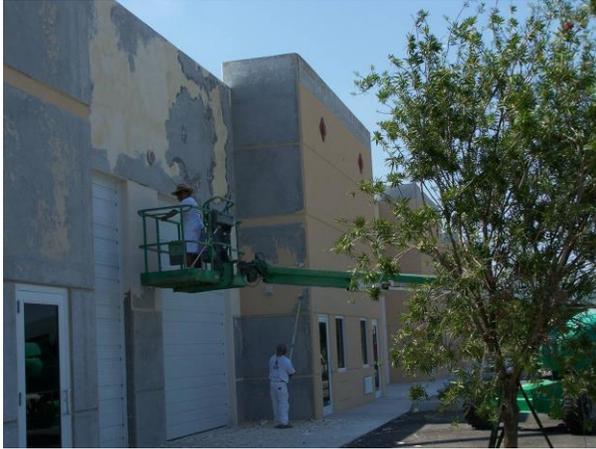
Photo 9

There are a few issues to be concerned about when painting new concrete. The surface of new concrete is often very hard and slick. The warehouse shown in photo 9 had to be stripped, acid etched, and repainted because good mechanical paint adhesion was not established.

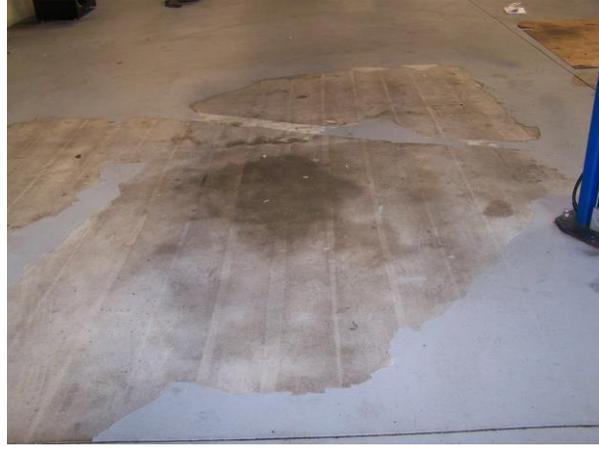
Laitance is a thin layer on the surface of new concrete that consists of fine particles due to the upward migration of water during the placement and curing process and often occurs on concrete floors. This concrete layer is of low strength and should be removed when surface preparation is performed, preferably by shot blasting. Photo 10 shows what can happen when a concrete floor is not properly prepared.
