Coatings Consultants Inc.

MAGIC IN A CAN!

By Bob Cusumano

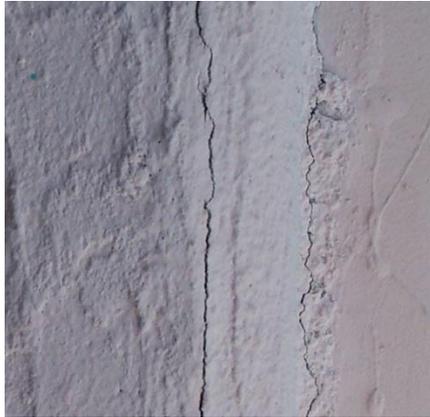
Photo 1

Elastomerics are applied at about five times to ten times the thickness of traditional acrylic paints. This higher film build has some advantages, like minimizing the appearance of surface imperfections and offering waterproofing properties, but some potential, severe disadvantages also exist. Because of its thickness and elasticity, elastomeric coatings result in a high degree of surface tension in their cured film. If the material to which it is applied has a low degree of integrity, as often happens with new, partially uncured cement plaster or old chalked or brittle paint, then the applied stress can result in delamination due to a cohesive failure of the substrate. Even though many elastomerics are said to "breathe", their high film build results in a lower vapor transmission rate than traditional acrylics and thus tend to hold moisture in the wall. Water can enter a building at the perimeter of doors, windows, through-wall penetrations, and through cracks. Although elastomerics will bridge hairline cracks if applied at their designated thickness, they are often not sufficient to satisfy the many structural or settling cracks that appear as shown in photo #1.

3. When you use elastomeric coatings you don't have to patch. Wrong again. Elastomerics only bridge hairline cracks. Proper repair of structural and moving cracks is critical to prevent water from getting behind the coating.

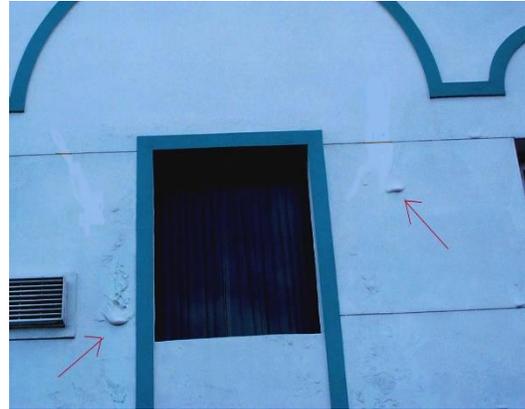
Photo 2

While elastomeric coatings are waterproof, they will not tolerate any moisture that can get behind the coating film. Therefore, if and when any cracks do develop, large areas of delamination will result. When a stucco surface that has been coated with an acrylic develops a crack, water vapor can pass through the film and a small area of discoloration is usually the result. Water vapor does not pass readily through the thicker, tighter elastomeric and catastrophic failure may occur.

Photo #2 shows "water bagging" on the wall of a building where water has entered through cracks above the raised accented stucco trim.

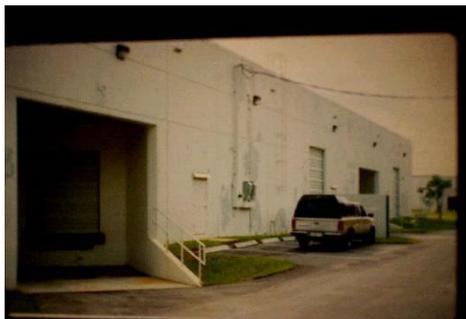
Photo 3

When applied to cementitious surfaces, like concrete, cement plaster, and concrete block, the combination of moisture and a highly alkaline condition can cause total chemical degradation of the coating system by a process called saponification, where the resin turns into soap. Photo #3 shows a concrete tilt up warehouse that has been finished with an elastomeric coating. In this instance, an alkyd primer was used. Alkyd resins are particularly susceptible to saponification. Because concrete retains a great deal of moisture and the elastomeric topcoat retards its evaporation, the moist, alkaline environment created destroyed the alkyd primer and literally "floated" the elastomeric off the wall (photo #4).

2. The protection comes from the top coat of elastomeric coating; you can prime with anything. No. Often severe attack on the coating comes from the back. The primer must be able to resist alkalinity and support the stress of the cured elastomeric coating film.

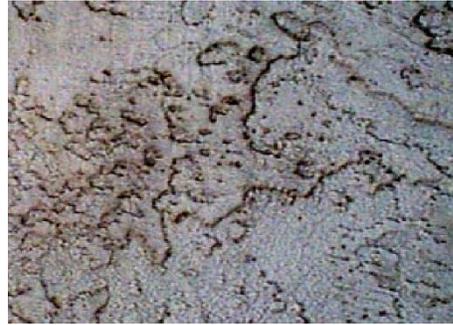
Photo 6

As depicted in photo #6, some elastomerics have a tendency to collect dirt, often due to the migration of plasticizers to the surface. Elastomeric coatings typically have several surface pores that can also hold dirt. Elastomerics typically don't chalk. A slight amount of chalking is a desirable feature because it allows dirt to be flushed away when the surface is washed by rain. When the coating film is very soft, as is often the case with elastomeric coatings, then the dirt becomes embedded in the film and cannot be removed by pressure cleaning. Photo #7 shows a sample at 60X magnification where dirt is visible on the surface after scrubbing with soap and water.
