## A WHITER SHADE OF PALE

By Bob Cusumano

This case involves color change on the exterior of an assisted living facility that was constructed in the year 2000. The specifications called for the use of two coats of acrylic flat finish paint on exterior concrete and stucco surfaces. The color selected for the exterior walls was a bright yellow from an interior color chart.

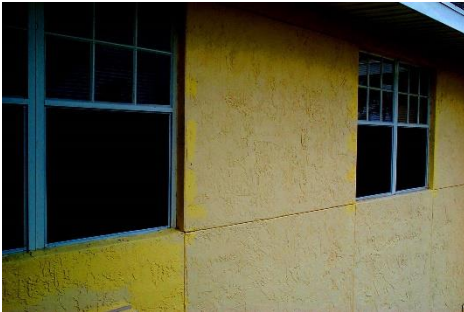
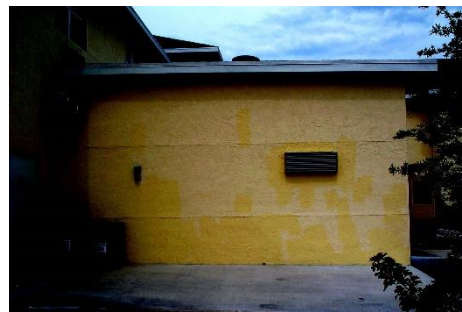
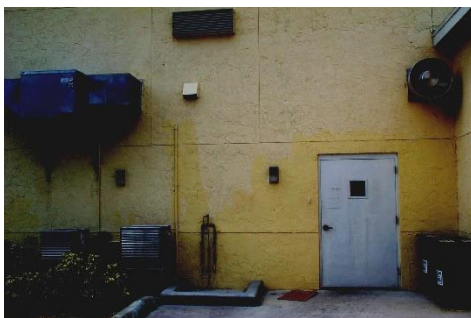
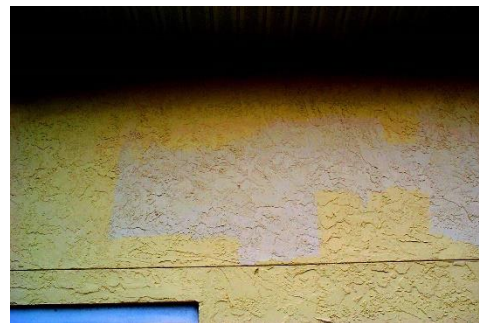
Approximately four months after completion of the exterior painting, the painting contractor returned to perform extensive touch up. About six months later, the owner called to complain that the building was unacceptable due to non-uniformity of color. The building manager explained that the "blotchy" paint appearance was not originally apparent, but has gotten progressively worse since first noticed. A visual inspection of the exterior walls indicated that certain wall areas were distinctively different in color than other areas. These conditions are depicted in photographs #1 through #4.

It is clear that the drastic color difference between dark yellow areas and light yellow areas as shown in the photos is due to some areas being repainted after the original application. The discoloration has a very distinct rectangular "block" pattern which is a result of touching up with a roller. This condition was confirmed by microscopic observation where the darker yellow coat could be clearly identified as overlaying the lighter yellow color. This was also confirmed in thickness tests.

Obviously, immediately after the touch up painting was performed, this drastic color difference did not exist. If it did, the painter would not continue to repaint with a color that did not match. Chemical oxidation tests performed on the new touchup paint indicated that it has a stable pigment. Therefore, it appears that the originally applied paint faded over time due to containing unstable pigments, whereas the touch up paint did not. Therefore, the color difference between the original unstable paint and the new stable touchup paint became obvious.

1. Always save enough paint from the original batch to perform touch up painting.
2. Make sure that colors selected for use are stable enough to be used in exterior exposures

3. Order one or two factory batches, rather than several small store tinted batches when possible for a large project.

4. Don't assume that different batches or paints will "weather" in the same fashion.

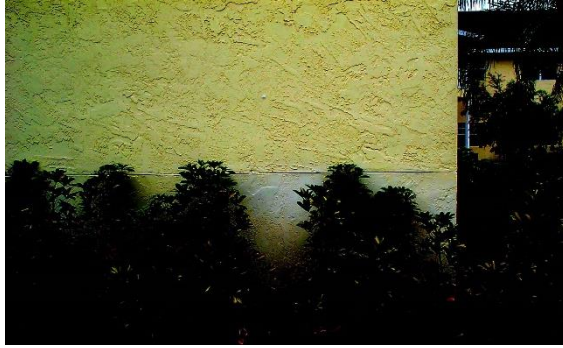
Photo 5

A few ground level wall panels were nearly white in color as shown in photo #5.

This condition was found only at a few locations and only on very low building panels. It is our understanding that maintenance personnel may have applied chemicals for the eradication of rust stains that may have contributed to the degradation of the paint at these areas. Based on the chalk tests performed, "chalking" is not the major reason cause of paint discoloration, except at these few areas.
