Coatings  
Consultants  
Inc.

## LIKE A MOVIE STAR, YOU WANT TO AVOID DEFECTIVE FILMS

By Bob Cusumano

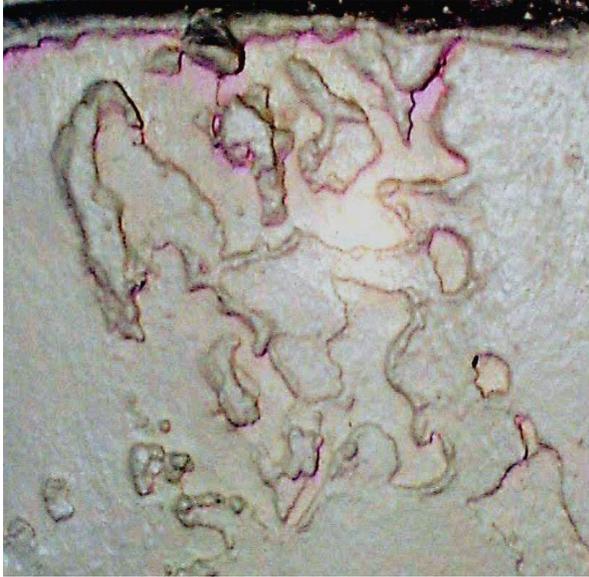
Photo 1

Paint coverage that is too thin can result in improper protection of the substrate and depending on the substrate, lead to such defects as incomplete hide or transparency, missed spots or holidays (photo 1), premature rusting, alkali burn (photo 2), and premature chalking.

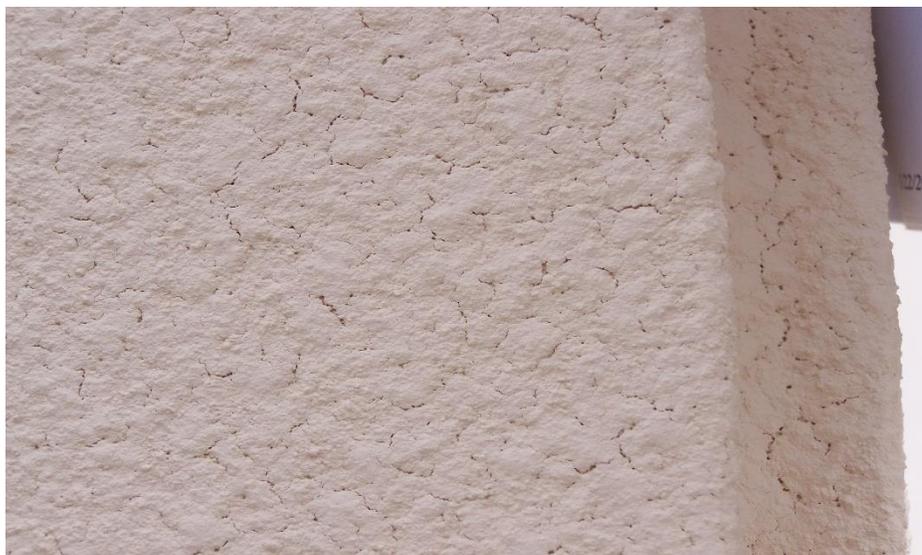
Photo 3

In our industry, more is not necessarily better. Coating thickness that is too thick can also result in various deficiencies. Mud cracking is a defect that resembles the appearance of dried mud (photo 3). Mud cracking often occurs when a coating is applied at greater than its recommended dry film thickness and the top surface of the paint dries faster than the underlying coating. This creates stress on the surface of the film, resulting in cracks.

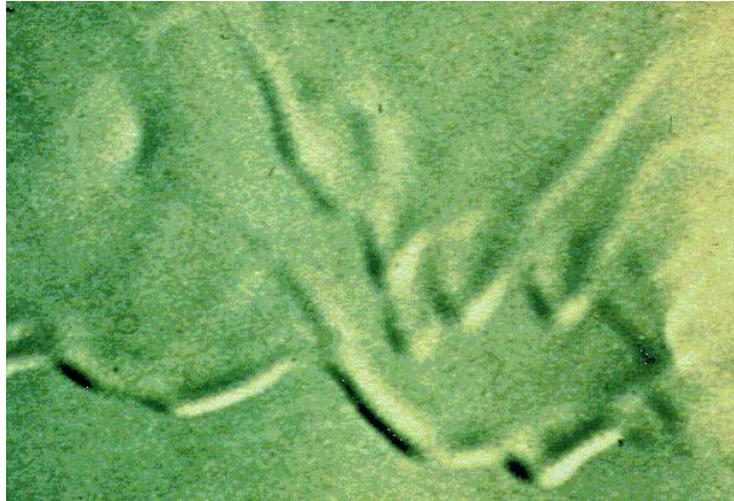
Photo 4

Runs, sags, or curtains (photo 4) are terms used to describe paint film defects that result when paint moves downward due to gravity before setting on a vertical or angled surface. These defects are usually the result of applying the coating at an excessive thickness or thinning the coating beyond its recommended amount. Wet or extremely humid conditions can contribute to

this phenomenon when latex paints are applied. These defects can also be the result of application to a surface that is hard and glossy. In this instance, the surface cannot adequately “hold” the paint and must be abraded prior to painting.

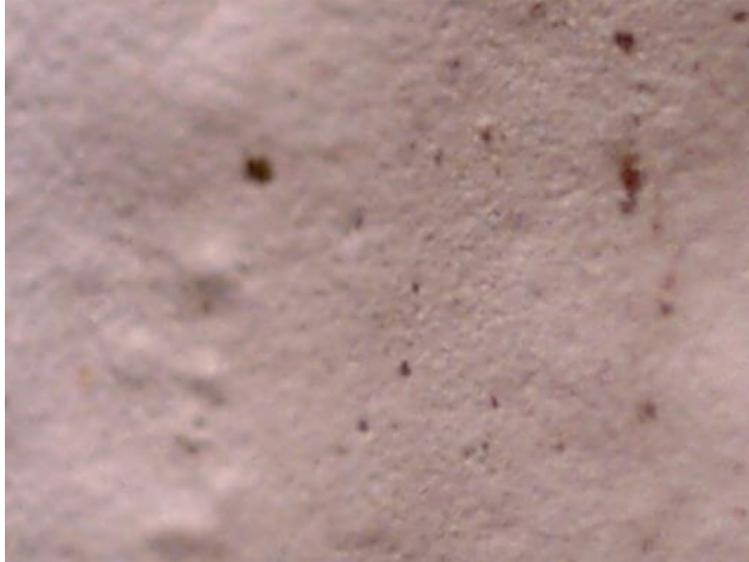
Photo 5

Pinholes are small voids in a coating film, often extending to the substrate (photo 5). When a coating is applied too heavily, then the solvent in the coating may become trapped. When the solvent escapes and the paint has already set to the point where it will not flow into the defect, then pinholes will occur. Other causes of pinholing include trapped moisture, insufficient or contaminated spray application, and trapped air during application. Pinholes will compromise the coatings ability to protect the substrate. This is particularly concerning when the substrate is susceptible to external influences that can cause corrosion of the substrate in the case of rust or water intrusion.

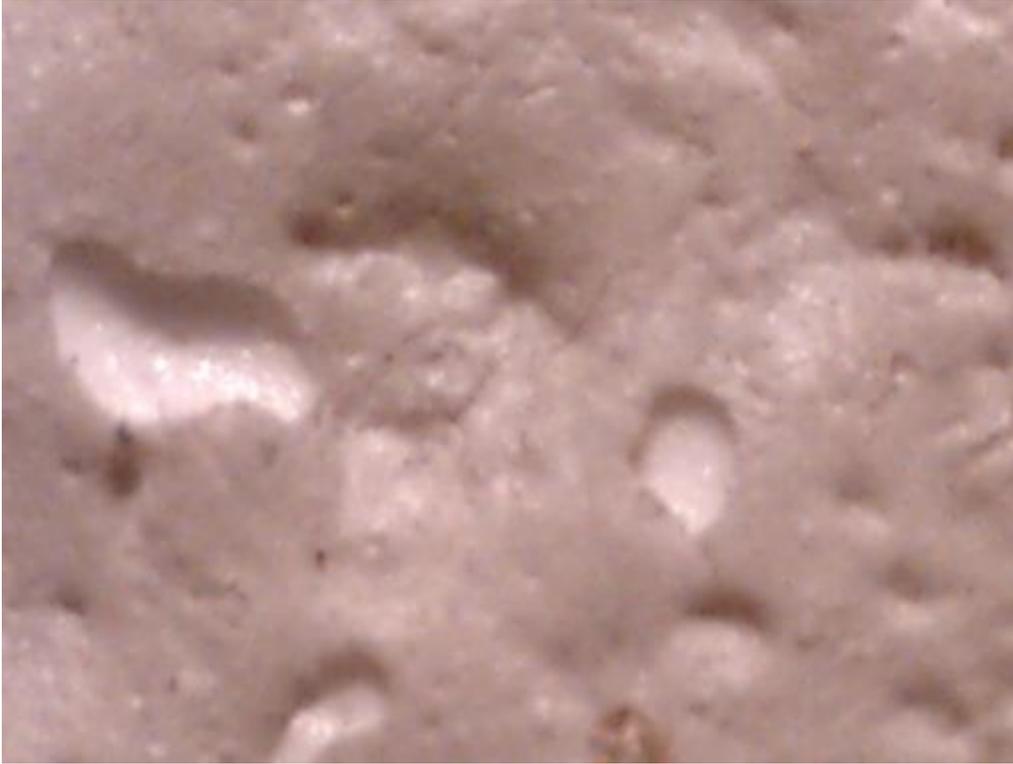
Photo 6

Craters are deep depressions, but unlike pinholes, they do not extend through the coating film. While the protective qualities may not be severely compromised in these instances, appearance often is. Craters will reflect light differently as compared to adjacent areas where the coating is smooth. This can result in a darker appearance. Craters are also capable of trapping and holding dirt, moisture and other contaminants which can lead to mildew growth in exterior applications or compromise the appearance due to discoloration (photo 6). This phenomenon often occurs with thicker coatings like elastomerics.

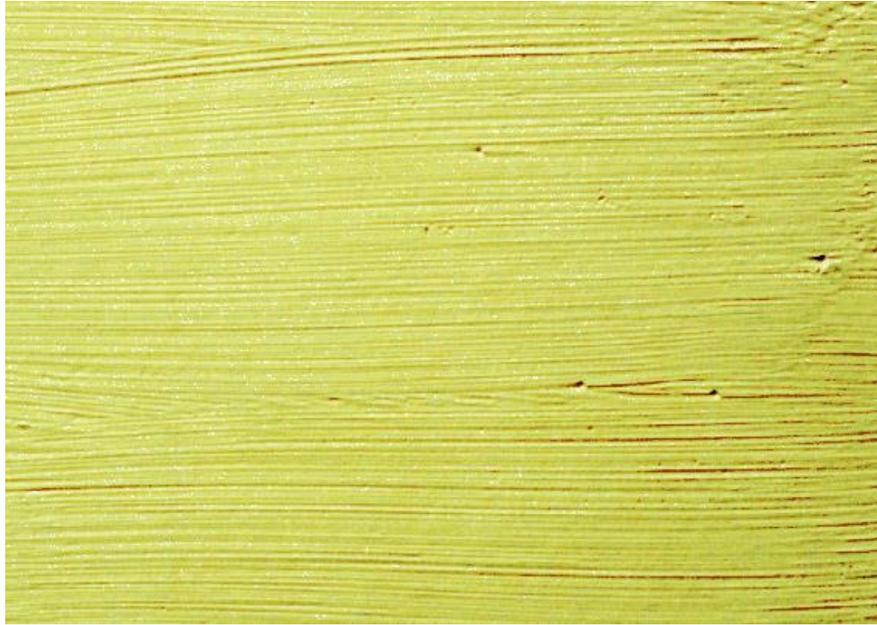
Photo 7

There are also various defects that are attributable to the paint application equipment utilized. Brush marks are closely spaced ridges and valleys visible in the painted finish (photo 7). These may be caused by brushing on a viscous paint without properly thinning the material or using the wrong thinner, using poor quality or worn brushes that do not level the paint, or brushing on the paint under environmental conditions that cause it to dry too quickly to allow self leveling of the material.

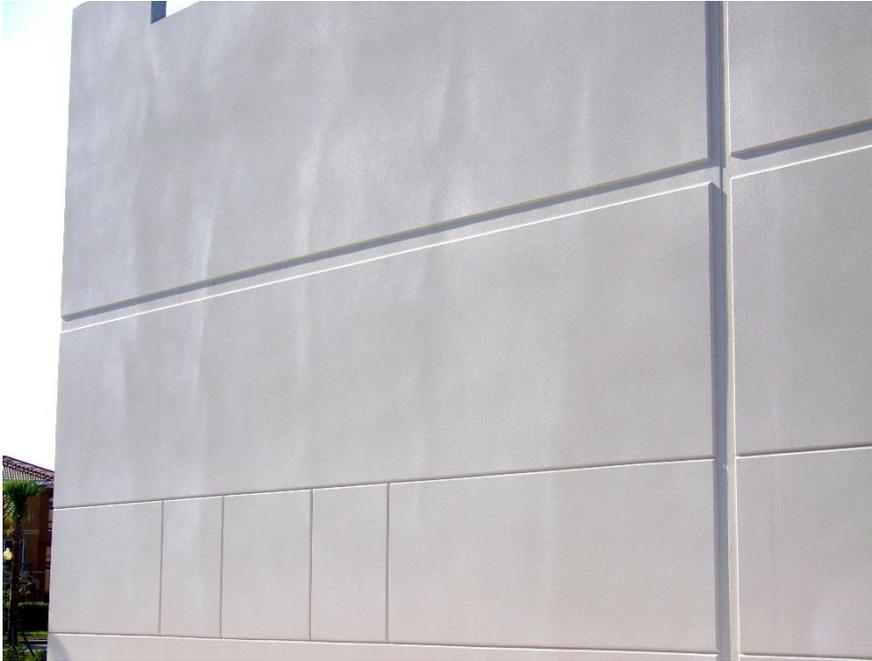
Photo 8

As is the case with brush and roller application, application of paint by spraying can result in uneven paint application that causes visual defects. Spray marks can result from improper application techniques or the use of worn spray tips (photo 8). The potentially most expensive spray defect is failing to control overspray and causing damage to nearby vehicles, boats, and other expensive property.
